## ARCHAEOLOGICAL TESTING REPORT

<b>Report</b>	Archaeological testing report
<b>Project</b>	Derrygrogan Little Solar Farm
<b>Townlands</b>	Derrygrogan Little
<b>Parish</b>	Ballycommon
<b>Barony</b>	Lower Philipstown
<b>County</b>	Offaly
<b>Grid Ref</b>	ITM 640994, 729274
<b>Licence No</b>	25E0987
<b>Author</b>	Audrey Gahan
<b>Date</b>	19/12/2025

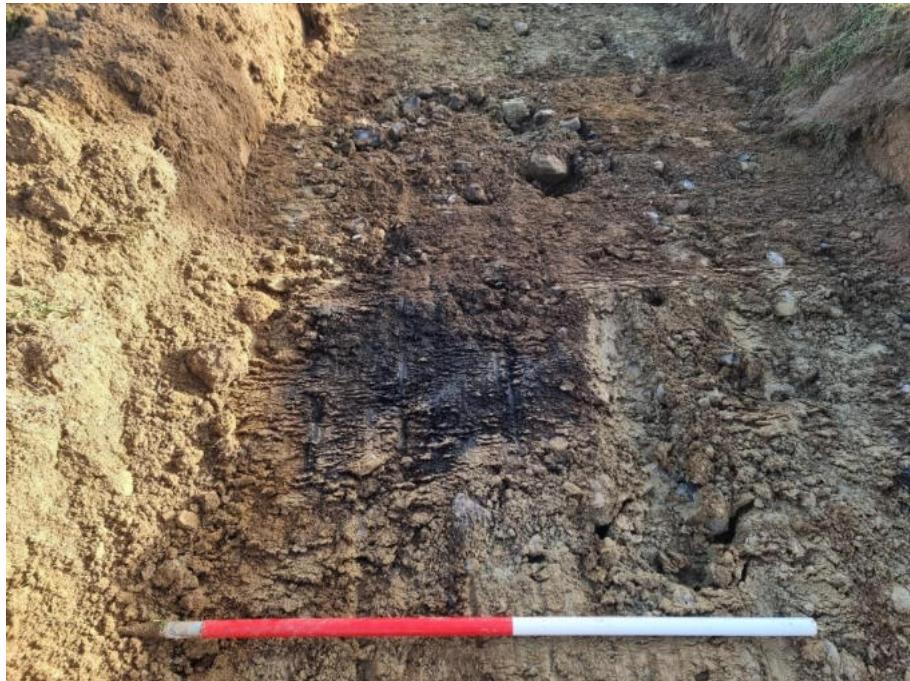
Trench 1 showed two anomalies, [7] and [8], on the geophysical survey, however, upon excavation of the trench, these anomalies were not visible. Instead, a small circular feature [18] measuring 0.6m north-south and 0.8m east-west was identified approximately 11m from the western end of the trench (plate 1).

Plate 1: Shot of [18] in trench 1, looking southeast

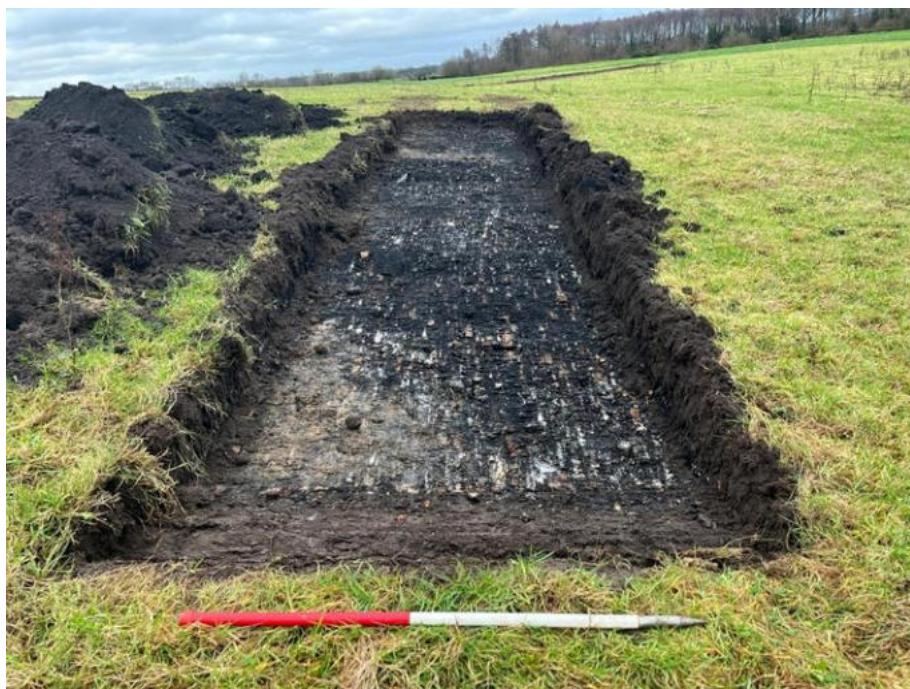
Trench 6 showed a single anomaly, which was not assigned a number on the geophysical survey. Excavation of the trench, which was 10m in length, revealed a deposit of black silty clay with frequent

cracked stone and charcoal inclusions which extended beyond the limit of the trench on all sides (plate 2). This deposit [19] likely represents a burnt stone mound.

Plate 2: Shot of [19] in trench 6, looking northeast

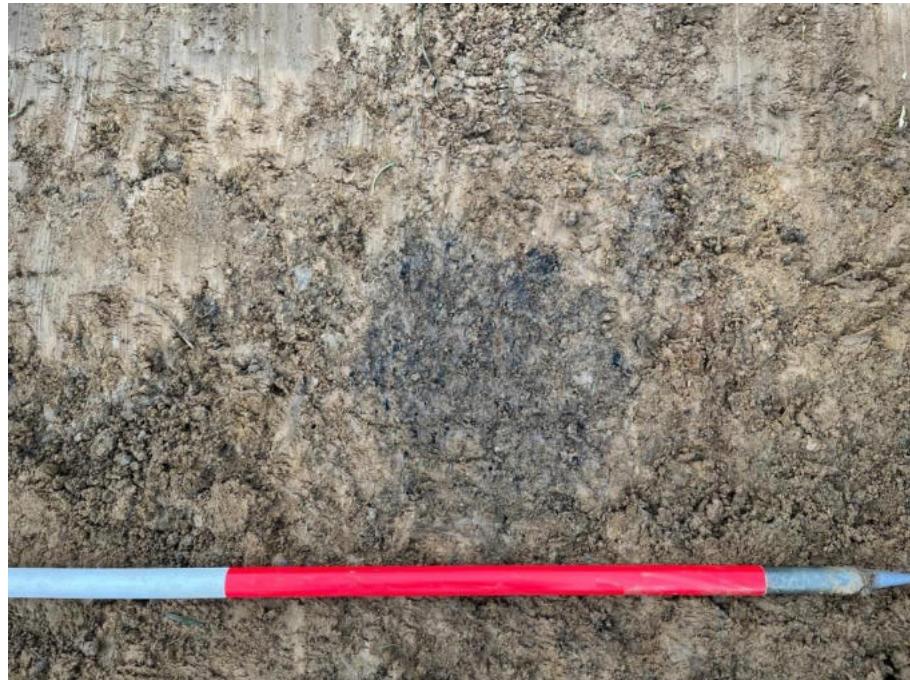
Trench 7 showed multiple small anomalies located through the trench and were collectively assigned the identification number [6]. Three features were identified within the trench which may correspond to the anomalies shown in this area. One of the features [6.1] was circular in plan and was located in the western half of the trench. A second feature [6.2] was oval in plan and located at the centre point

of the trench, and the third feature [6.3] was irregular in plan and located in the northern half of the trench. Feature [6.1] measured 0.2m north-south and 0.2m east-west (plate 3), while the other two features extended beyond the limit of the trench. Feature [6.2] measured 0.8m northeast-southwest and Feature [6.3] measured 2m northeast-southwest (plates 4 and 5).

Plate 3: Shot of the feature [6.1] located in the western half of trench 7, looking southwest

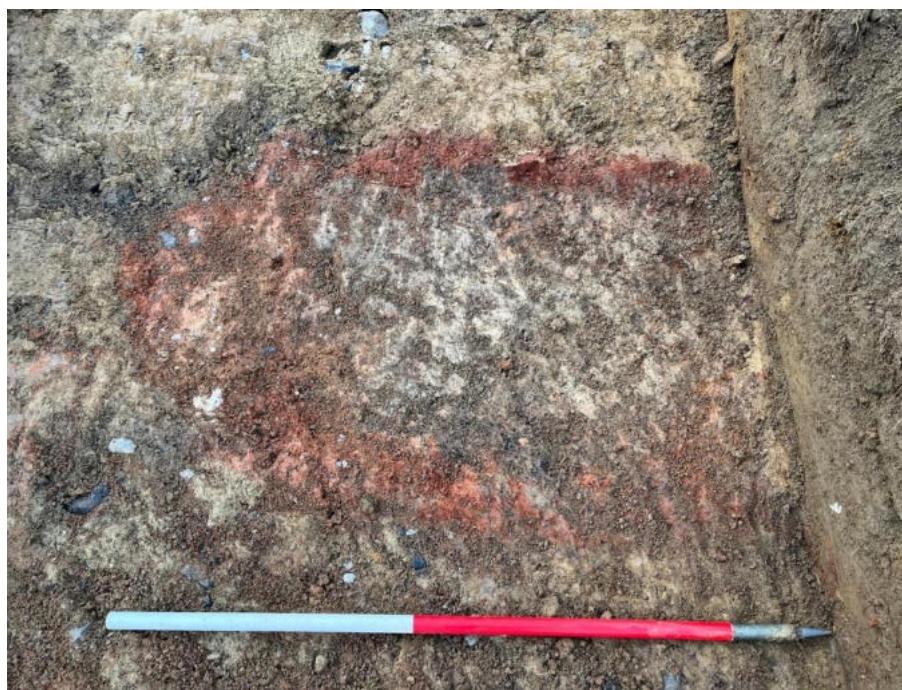
Plate 4: Shot of the feature [6.2] located centrally in trench 7, looking southwest

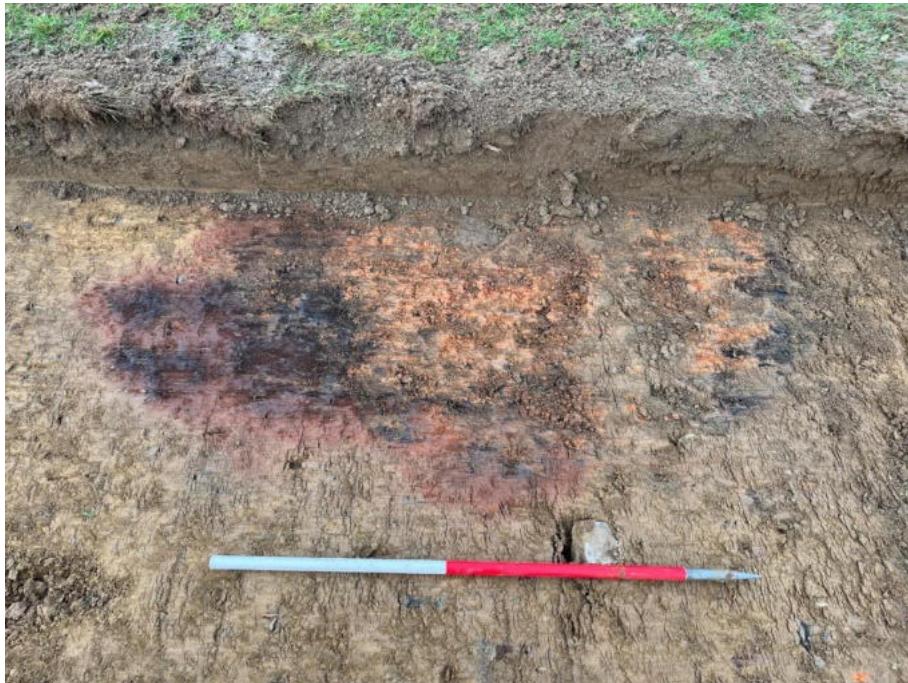
**Plate 5: Shot of the feature [6.3] located in the northern half of trench 7, looking northwest**

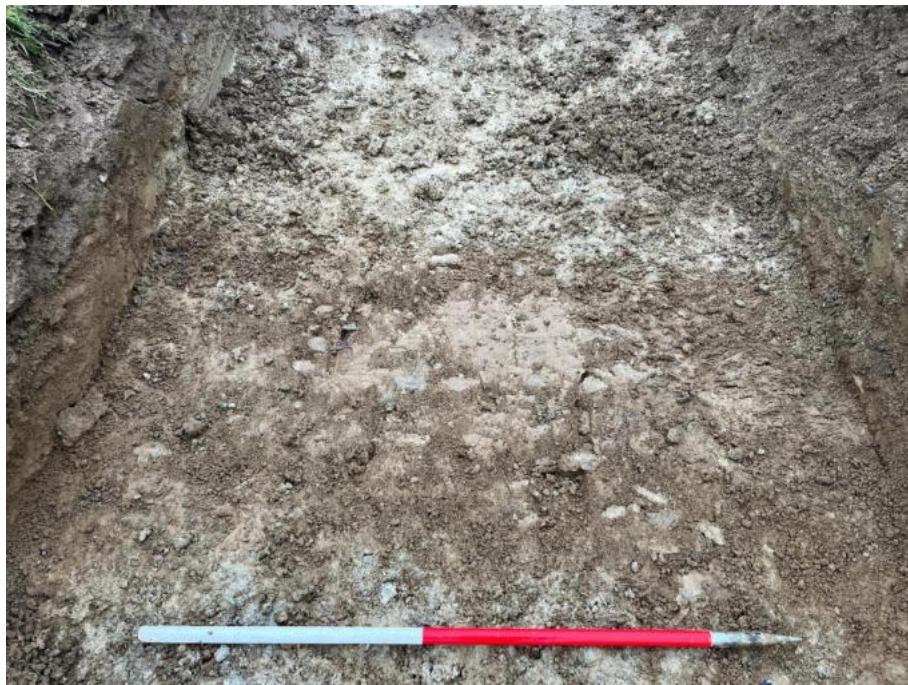
Linear features were identified following the excavation of trenches 11-13, 17, 22 and 23 (plates 6-12). The anomalies shown on the geophysical survey which correspond to these linear features are collectively assigned the identification number [2]. The linear features identified in the northern half of trenches 11 and 17, which have a maximum width of 1.1m, are likely to be a continuation of the same feature [2.2]. Similarly, the linear features identified in trenches 12 and 13, which have a maximum width of 1.2m, are likely to be a continuation of the same feature [2.3].

Plate 6: Shot of linear feature [2.1] located in the southern half of trench 11, looking north

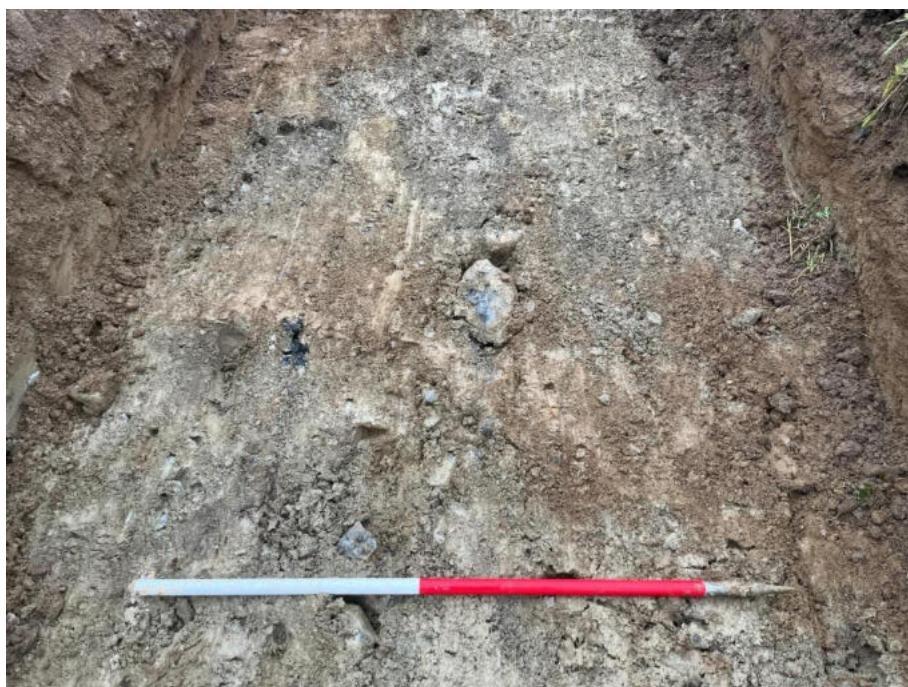
Plate 7: Shot of linear feature [2.2] located in the northern half of trench 11, looking south

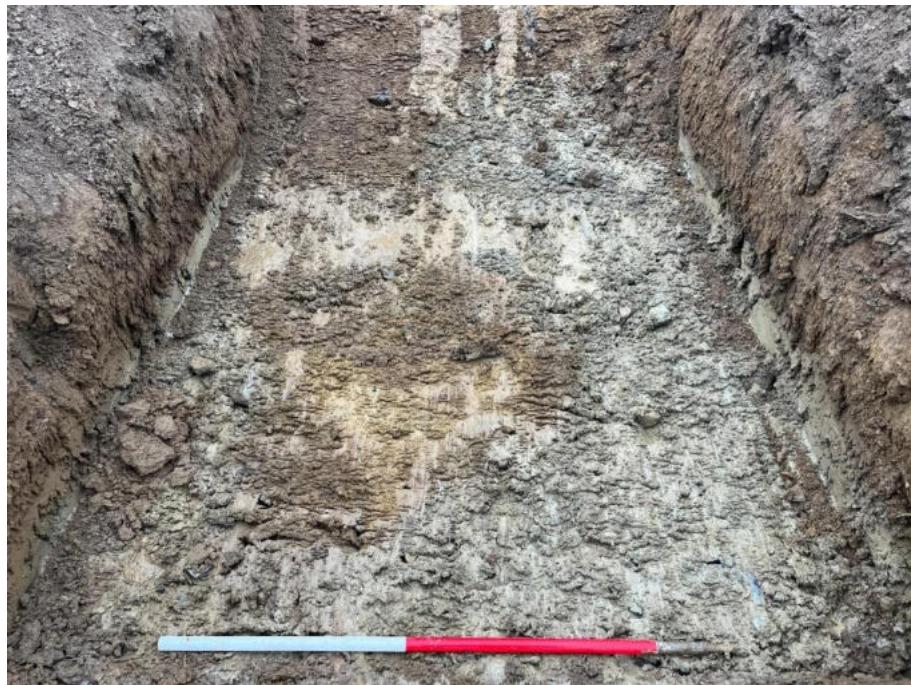
Plate 8: Shot of linear feature [2.3] located in trench 12, looking northeast

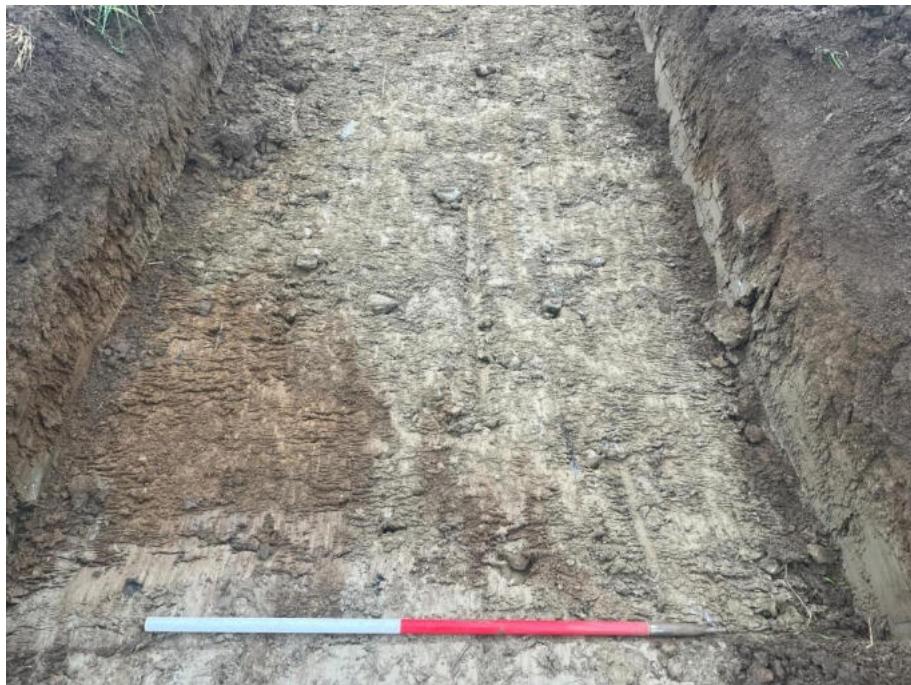
Plate 9: Shot of linear feature [2.3] located in trench 13, looking northeast

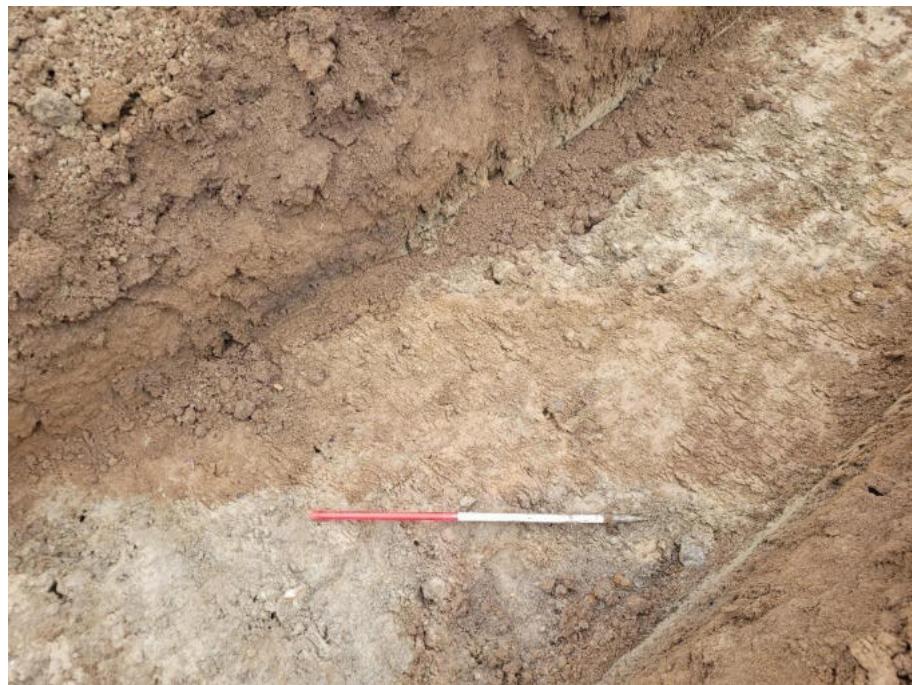
Plate 10: Shot of linear feature [2.2] located in the northern half of trench 17, looking north

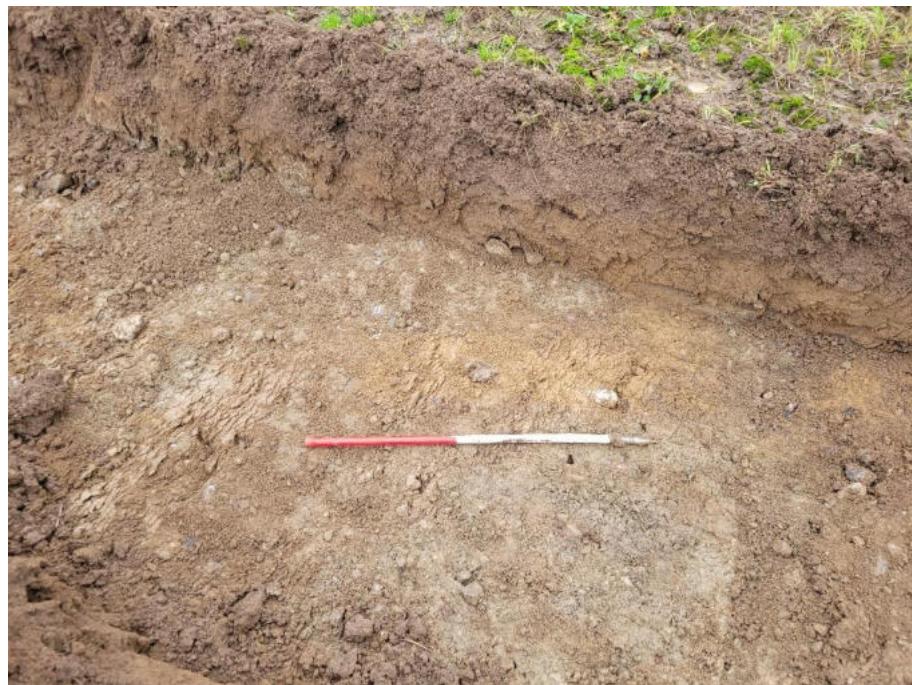
Plate 11: Shot of linear feature [2.4] located in the southern half of trench 17, looking south

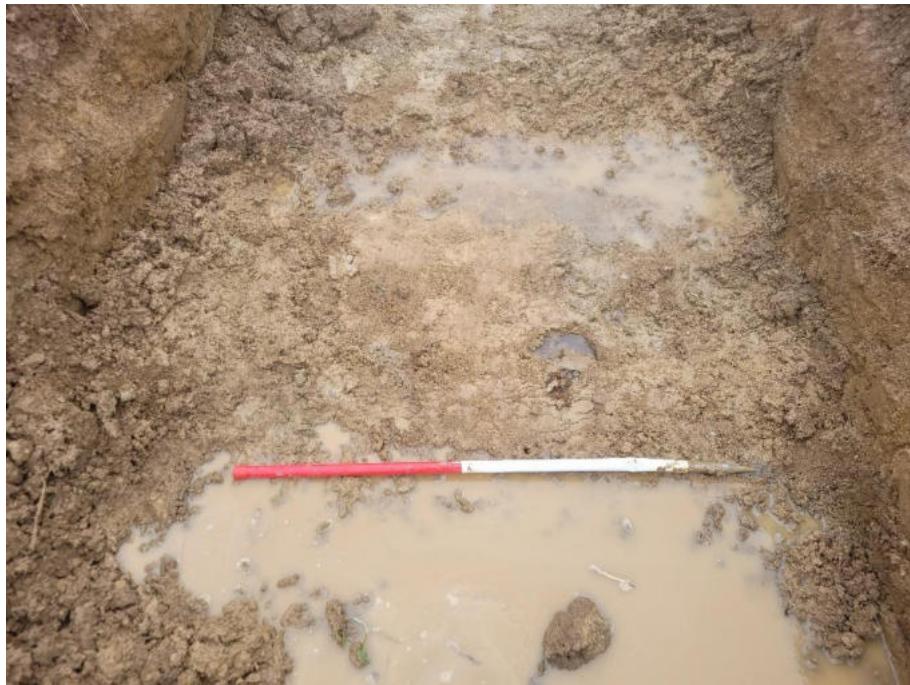
Plate 12: Shot of linear feature [2.5] located in trench 22, looking east

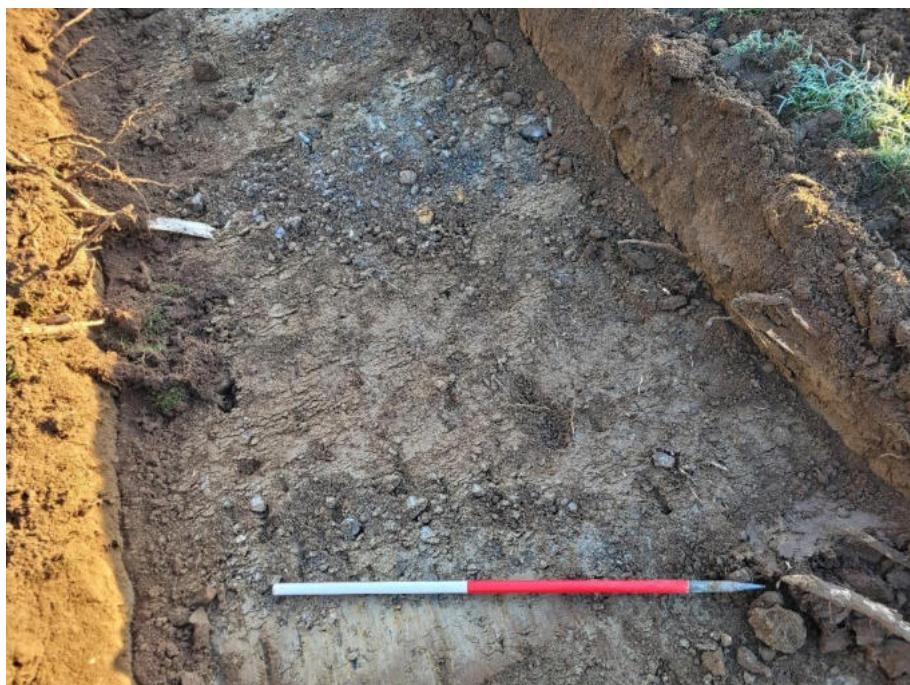
In addition to above mentioned trenches, trench 31 is one of a series of trenches located to target the proposed access road through site and trench 46 is one of a series of trenches located to provide preliminary assessment of the site. However, the geophysical survey did reveal a positive trend extending north-south through both of these trenches. Following the excavation of trenches 31 and 46, a linear feature [20] was identified in both trenches which corresponds to this trend (plates 13 and 14).

Plate 13: Shot of linear feature [20] in trench 31, looking northeast

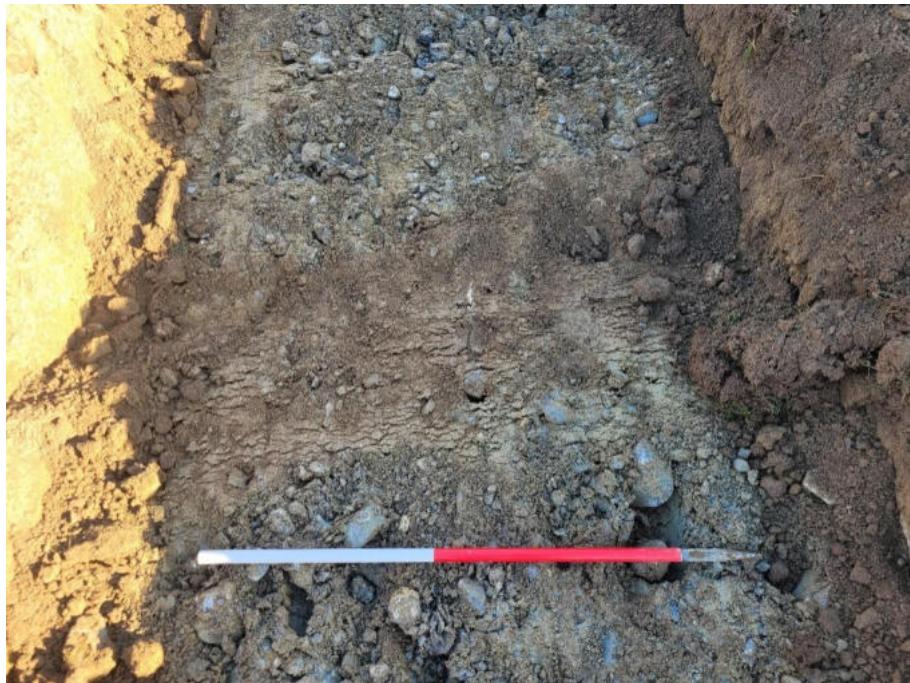
Plate 14: Shot of linear feature [20] in trench 46, looking northeast

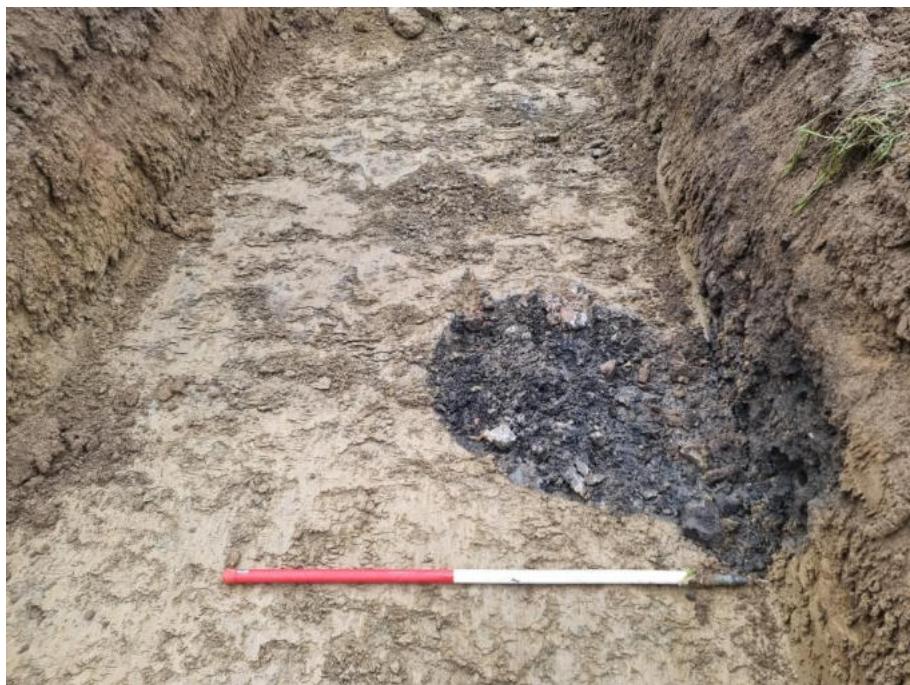
The excavation of trench 42 revealed a roughly circular feature extending beyond the limit of the trench (plate 16). The feature [22] measured 0.9m north-south.

Plate 16: Shot of feature [22] in the southern half of trench 42, looking north

Trench No.	Feature No	Description	Mitigation
42	22	Charcoal rich circular pit- high archaeological significance	Solar arrays to be erected on supports with concrete feet within area shown on figure 13. All cabling to be above ground.
62	23	Burnt mound- high archaeological significance	Solar arrays to be erected on supports with concrete feet within area shown on figure 13. All cabling to be above ground.

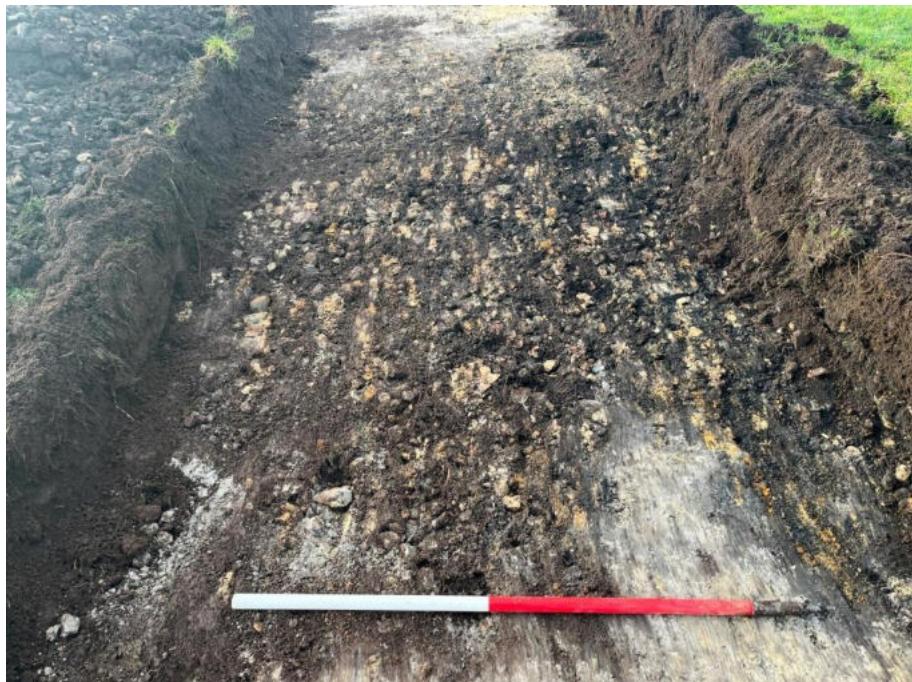
The excavation of trench 62 revealed a deposit of black silty clay with frequent cracked stone and charcoal inclusions (plate 17). The deposit [23] measured 3m northeast-southwest but extended beyond the limit of the trench to the northwest and southeast. This deposit likely represents a burnt stone mound.

Plate 17: Shot of [23] in trench 62, looking southwest

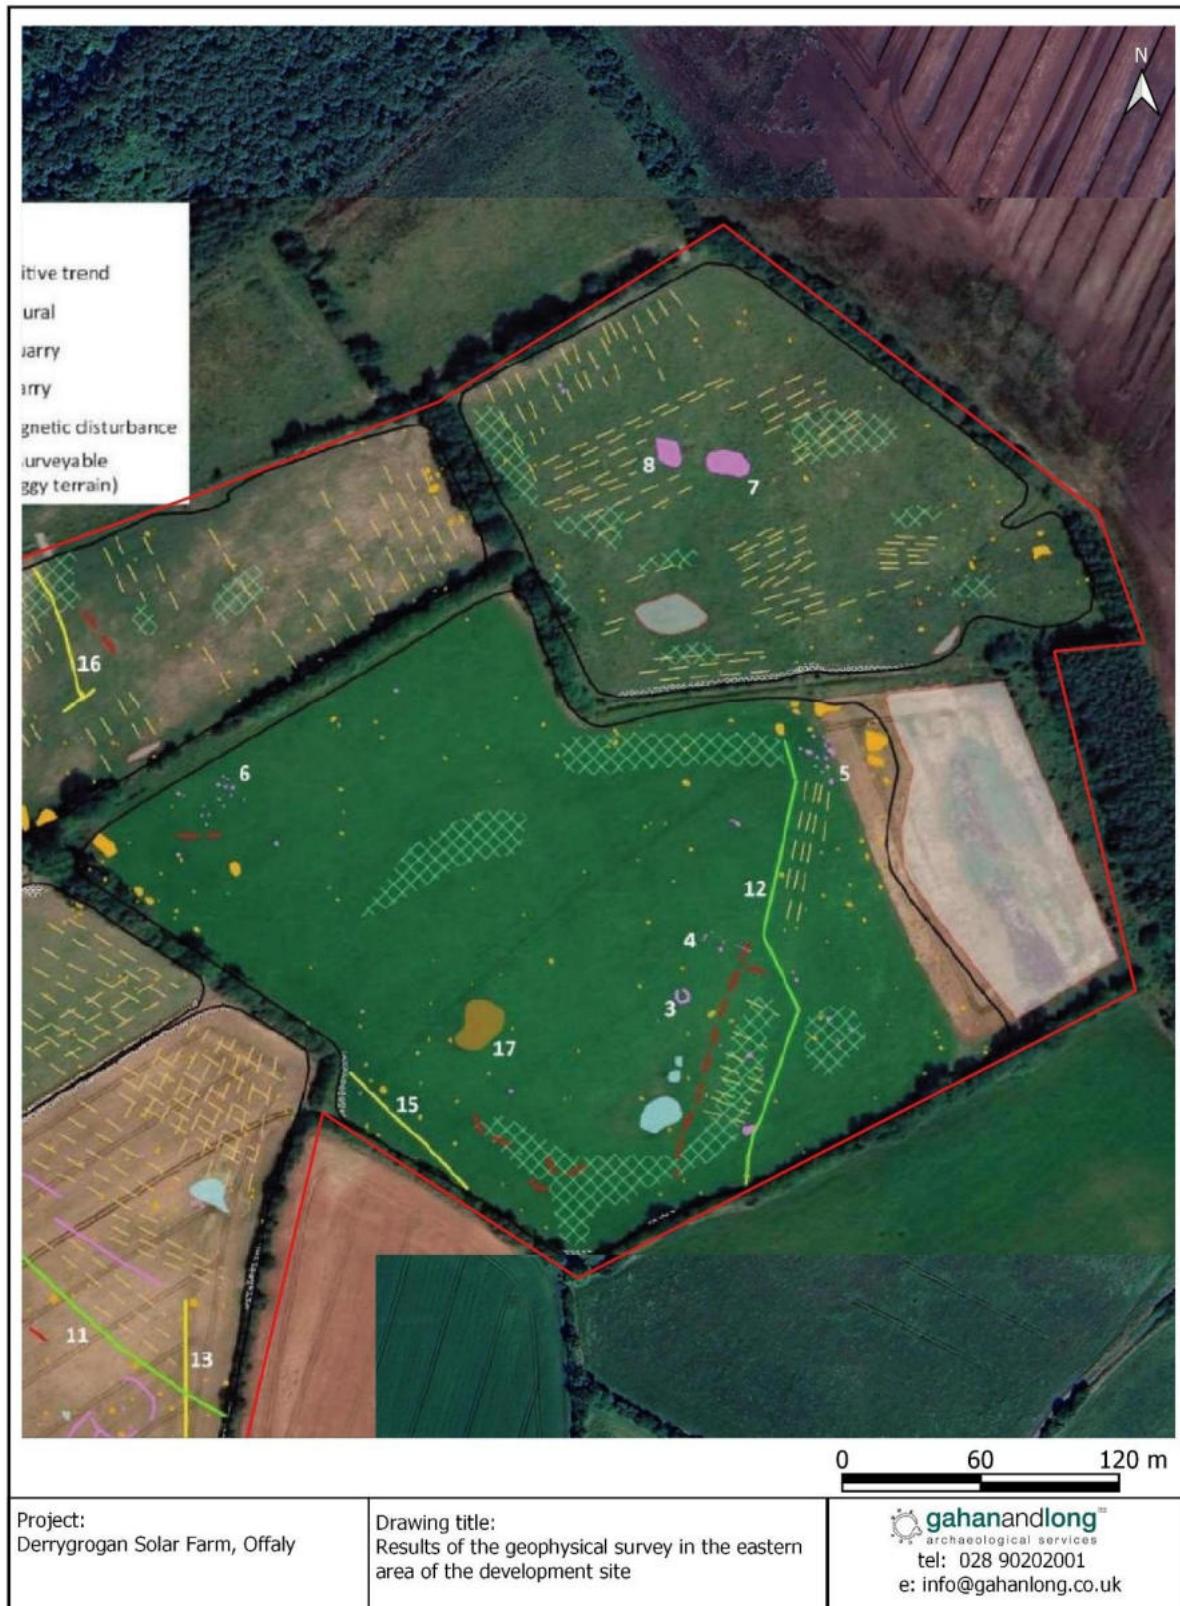
A geophysical survey of the application site was completed in May 2024 (licence no 24R0268). The geophysical survey identified extensive potential archaeological features across much of the development area (figures 6 and 7). The main concentration of features was located in the southern

area of the site. This included a c.25m-diameter ditched enclosure [1] which might be associated with two, weak positive lineations, possible ditches, that appear to extend from its southern circuit.

Other potential features detected by the survey include a possible c.5m-diameter penannular ring-ditch [3] and a curving line of discrete pits/spreads [4] that could represent part of a larger feature/structure of some type. Two separate clusters of 'pit-type' responses [5 & 6] may also be of archaeological interest, though a natural origin for these anomalies cannot be discounted on present evidence. The same may be true of two anomalies provisionally classified as burnt spreads [7 & 8] in the northeastern field of the survey area; these anomalies could equally reflect natural variations in the underlying soils.

Figure 6: Results of geophysical survey in the central area of the development site.

Figure 7: Results of geophysical survey in the eastern area of the development site.

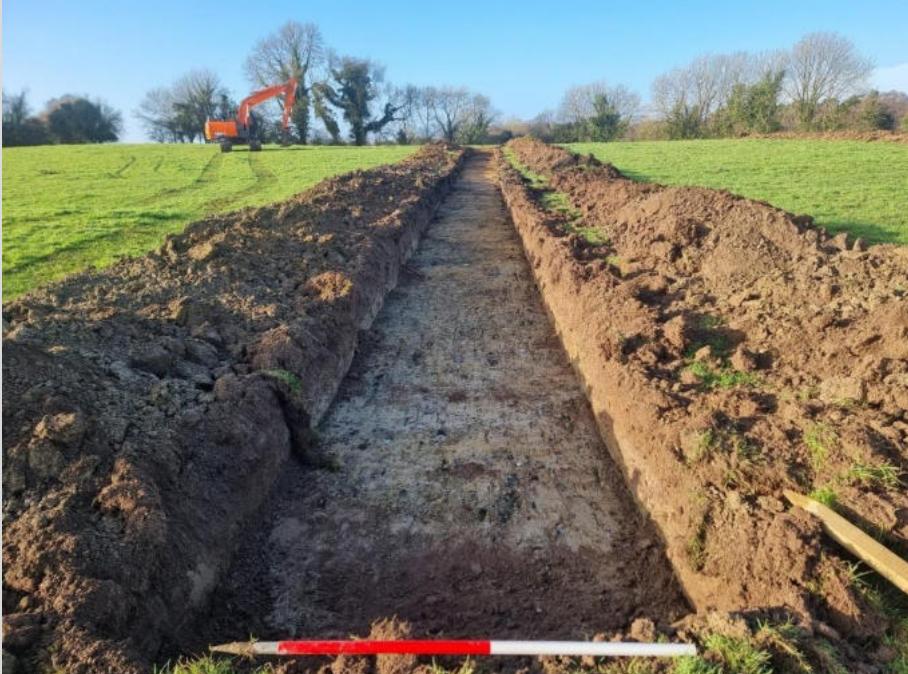
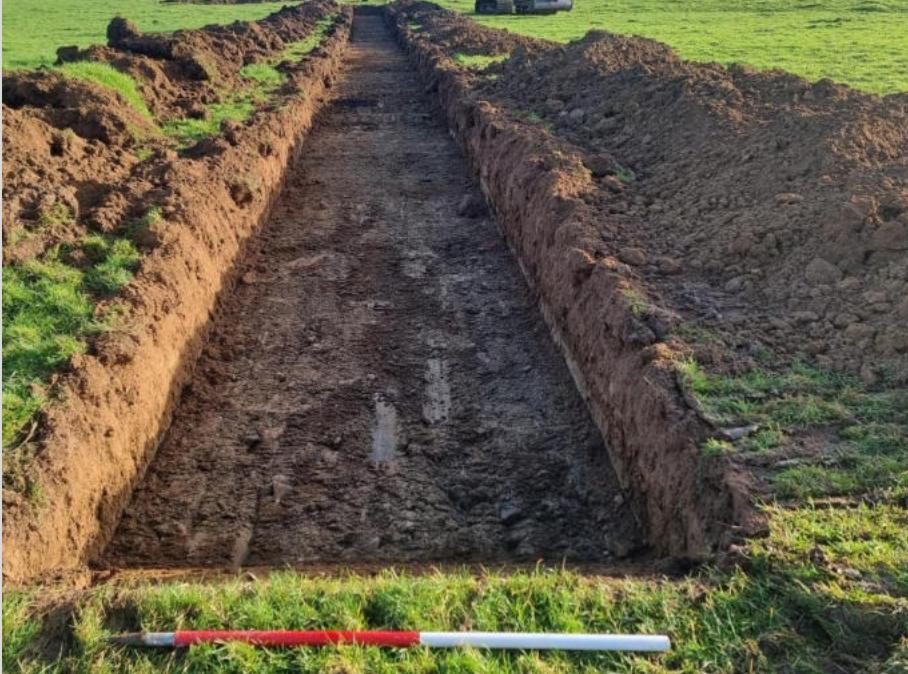
Trench Number	Length	Depth (m)	Archaeology Identified	Description
1	50m	0.5-0.6	Archaeological deposits identified	
				<p>Topsoil was removed directly onto subsoil which was a firm greyish-yellow silty clay with occasional angular stone inclusions.</p> <p>A circular feature [18] was identified in the western half of the trench. This feature is unlikely to be [7] or [8], which are shown to extend beyond the limit of the trench on the geophysical survey. [7] and [8] were not visible in the trench.</p>

<p>Looking northwest</p>

<p>Looking southeast</p>

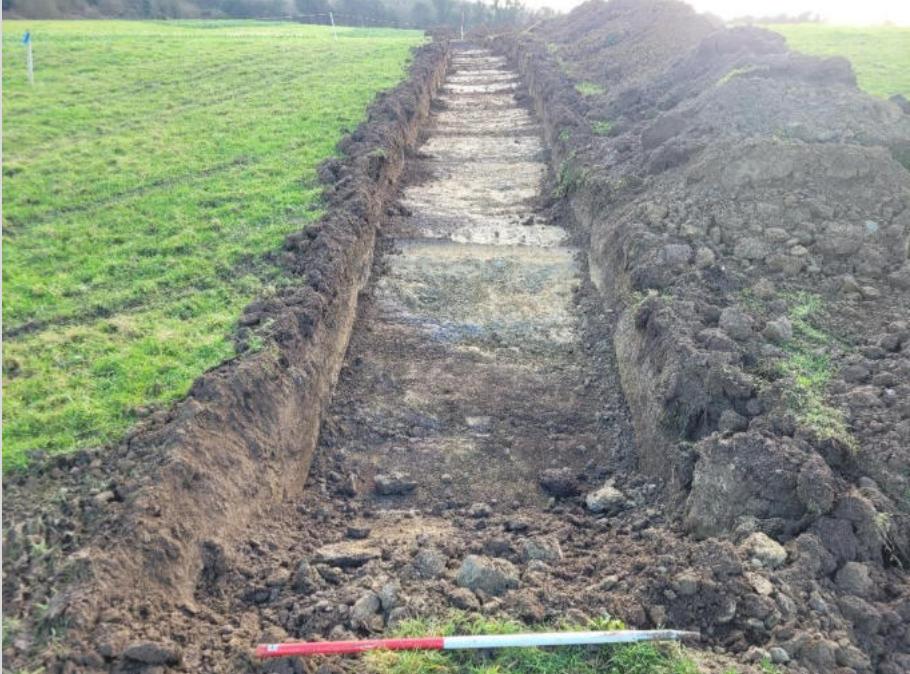
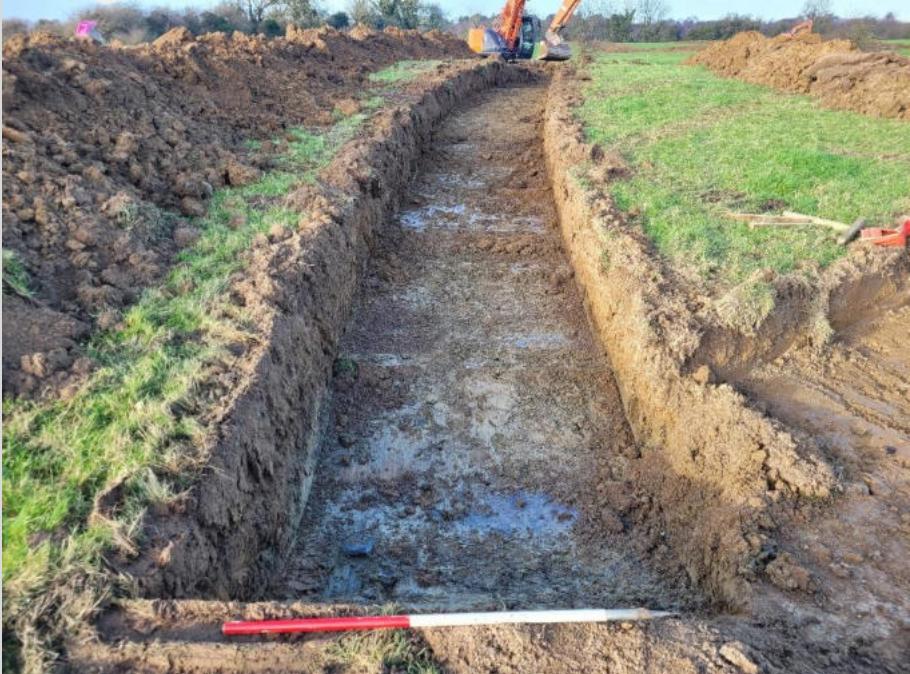
Trench Number	Length	Depth (m)	Archaeology Identified	Description
2	30m	0.5-0.7	No archaeological deposits identified

Looking southeast				Topsoil was removed directly onto subsoil which varied between a firm greyish-yellow silty clay and a brownish-orange silty clay. Feature [5], which was identified during the geophysical survey was not visible in the trench.

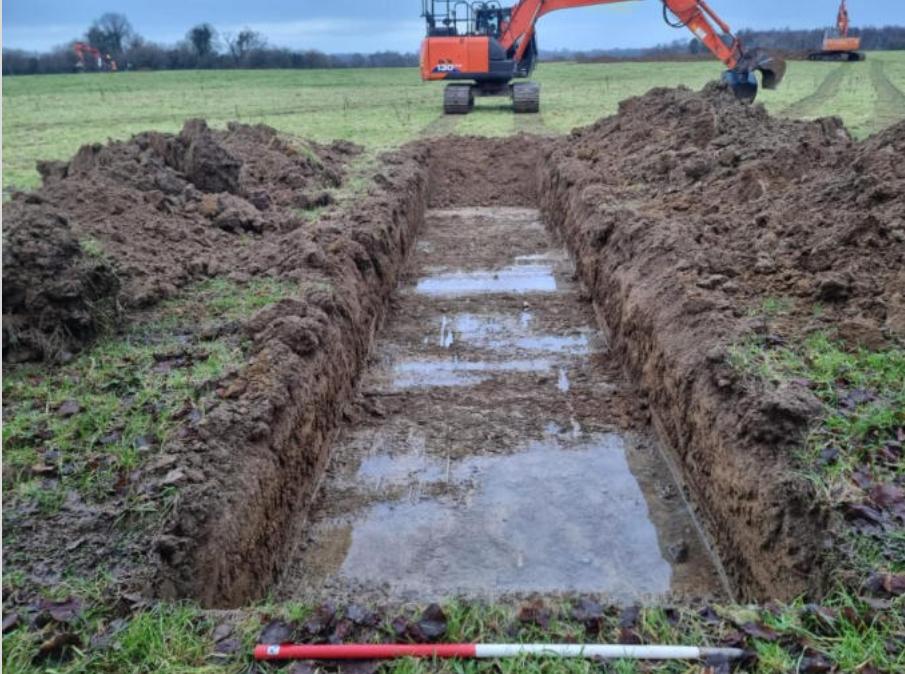
Trench Number	Length	Depth (m)	Archaeology Identified	Description
4	15m	0.5	No archaeological deposits identified	Topsoil was removed directly onto subsoil which consisted of a brownish-orange silty clay. The ditch feature [3] was not visible in the trench.

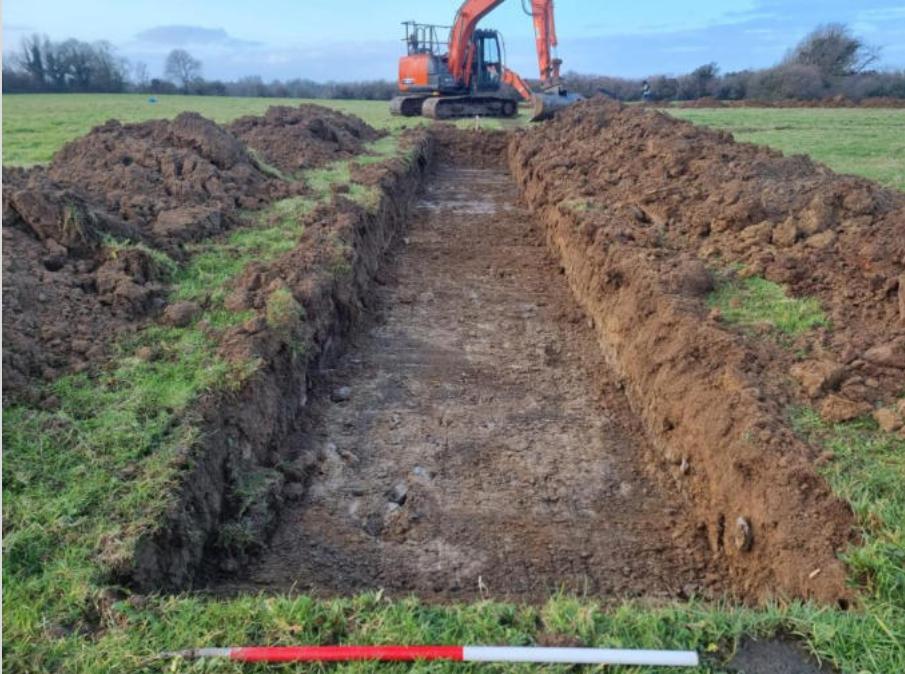
Looking west
Trench Number	Length	Depth (m)	Archaeology Identified	Description
5	15m	0.4-0.5	No archaeological deposits identified	Topsoil was removed directly onto subsoil which consisted of a brownish-orange silty clay. The curving line of discrete pits/spreads [4] was not visible in the trench.

Looking northwest

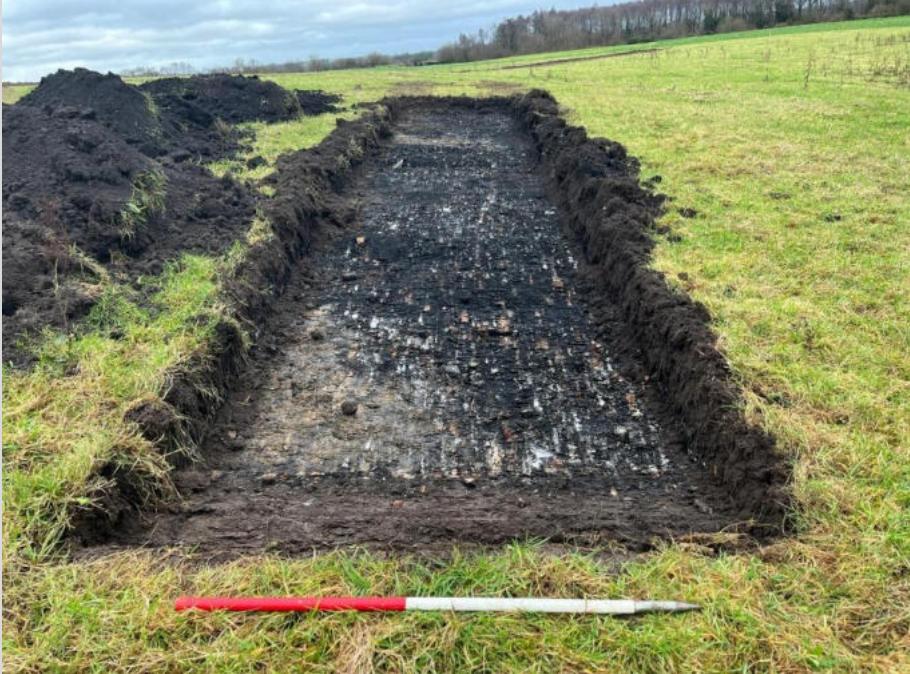
Trench Number	Length	Depth (m)	Archaeology Identified	Description			
6	10m	0.2-0.3	Archaeological deposits identified

<p>Topsoil was removed directly onto a black silty clay deposit with frequent cracked stone and charcoal inclusions [19]. This deposit was identified during the geophysical survey and represents a potential archaeological feature- most probably a burnt mound</p>			
Looking northeast							
Trench Number	Length	Depth (m)	Archaeology Identified				
7	25m	0.4	Archaeological deposits identified

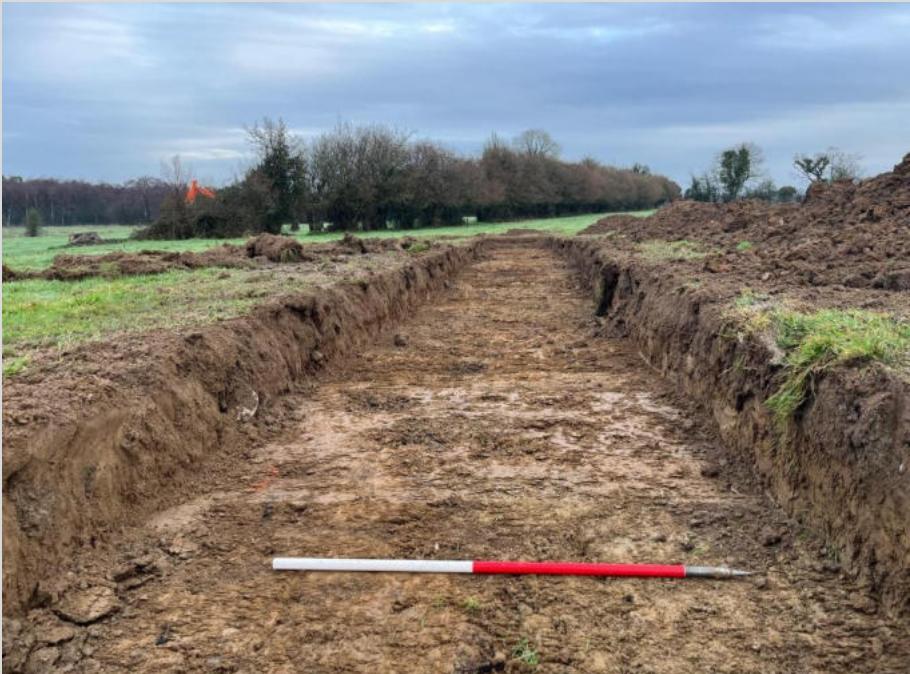
<p>Looking northeast</p>				<p>Topsoil was removed directly onto subsoil which consisted of a brownish-orange silt clay. Three features were identified in the trench. The features are located in the area marked as [6] on the geophysical survey.</p>

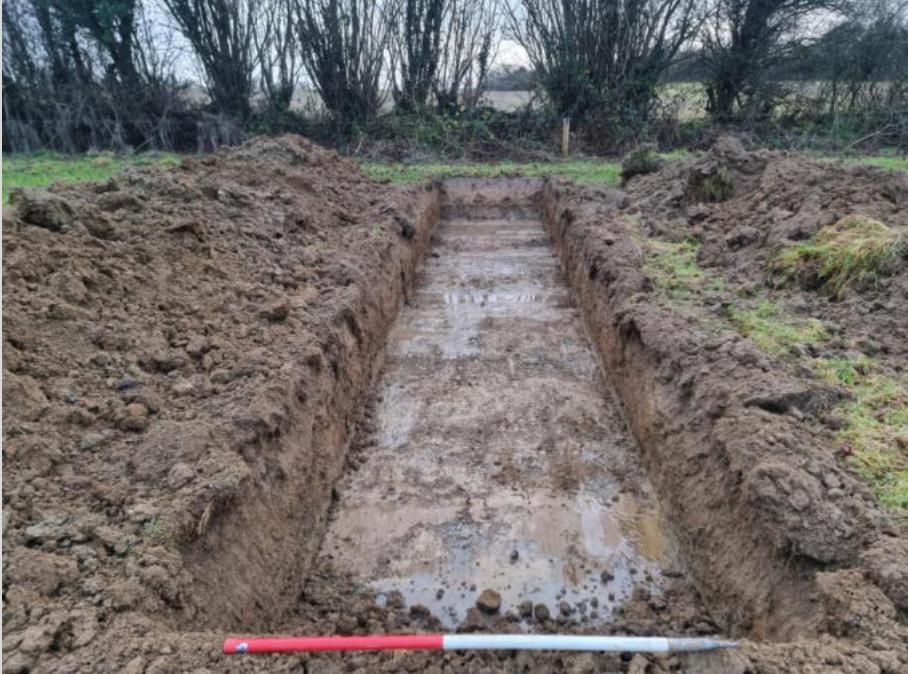
Trench Number	Length	Depth (m)	Archaeology Identified	Description
10	10m	0.5-0.6	No archaeological deposits identified

Topsoil was removed directly onto subsoil which consisted of a brownish-orange silt clay. The field boundary [15], which was identified during the geophysical survey, was not visible in the trench.
Looking southwest				
Trench Number	Length	Depth (m)	Archaeology Identified	Description
11	20m	0.6	Archaeological deposits identified

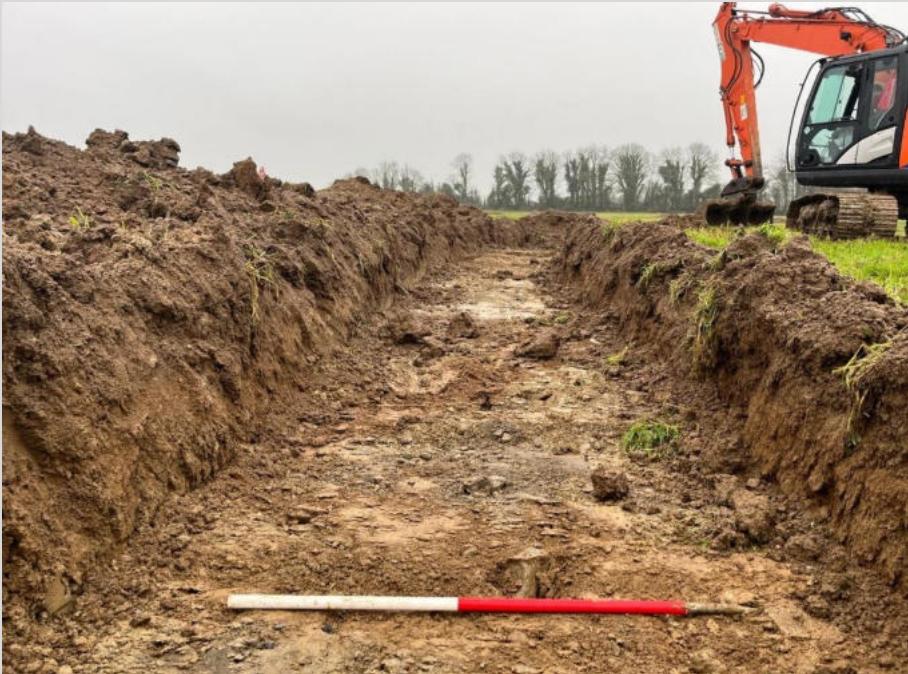
Topsoil was removed directly onto subsoil which consisted of a brownish-orange silt clay. Two linear features were identified extending northwest-southeast across the trench. These features are shown as [2] on the geophysical survey.
Looking north

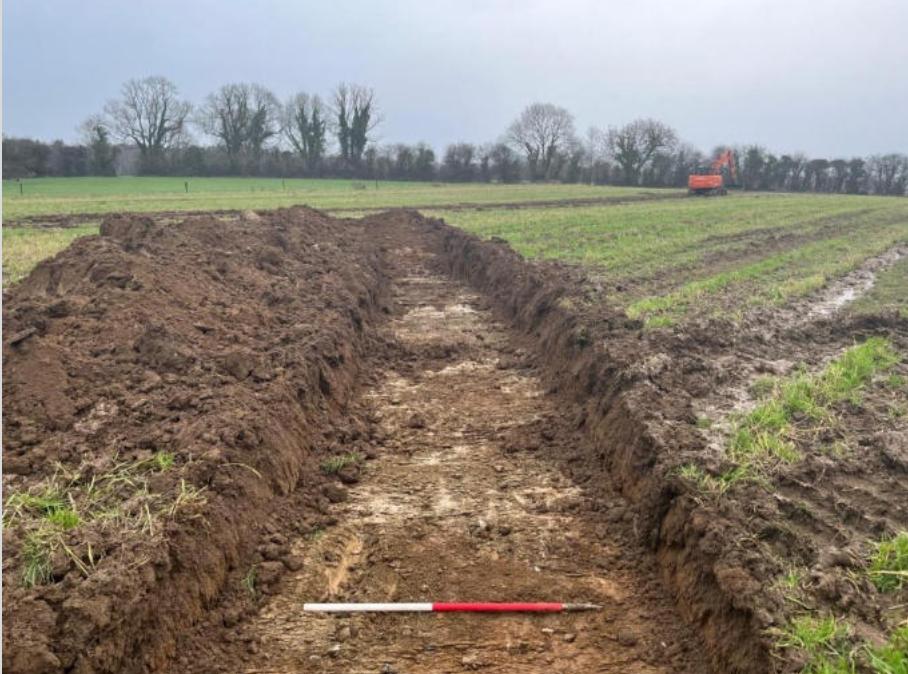
Trench Number	Length	Depth (m)	Archaeology Identified	Description	
12	10m	0.5-0.8	Archaeological deposits identified	Topsoil was removed directly onto subsoil which consisted of a brownish-orange silt clay. A linear feature was identified extending northwest-southeast across the trench. This feature is shown as [2] on the geophysical survey.

Looking northeast	
Trench Number	Length	Depth (m)	Archaeology Identified

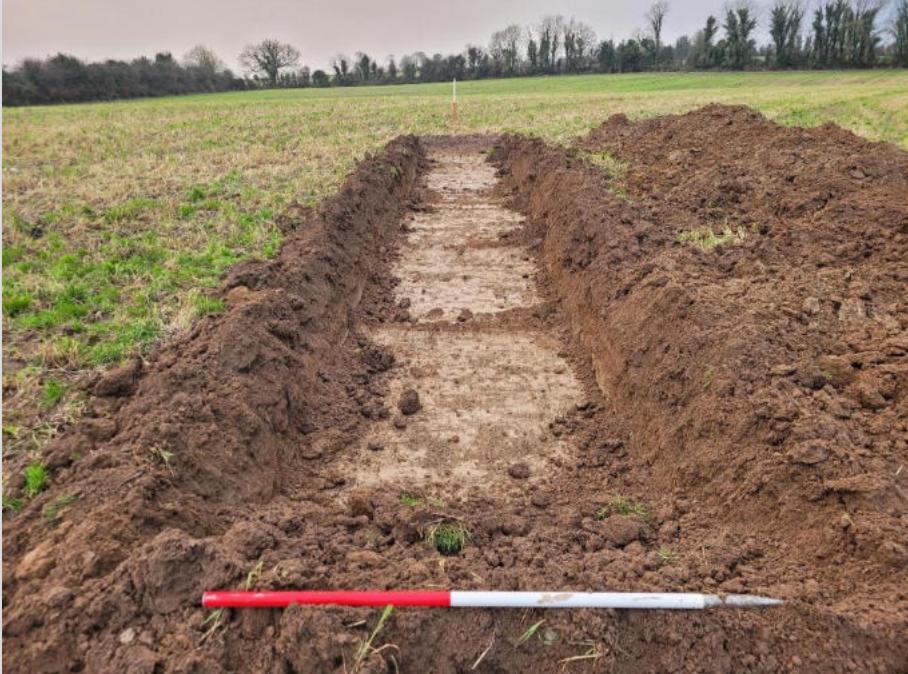
13	10m	0.5-0.6	Archaeological deposits identified	Topsoil was removed directly onto subsoil which consisted of a brownish-orange silt clay. A linear feature was identified extending northwest-southeast across the trench. This feature is shown as [2] on the geophysical survey.	
Looking southwest

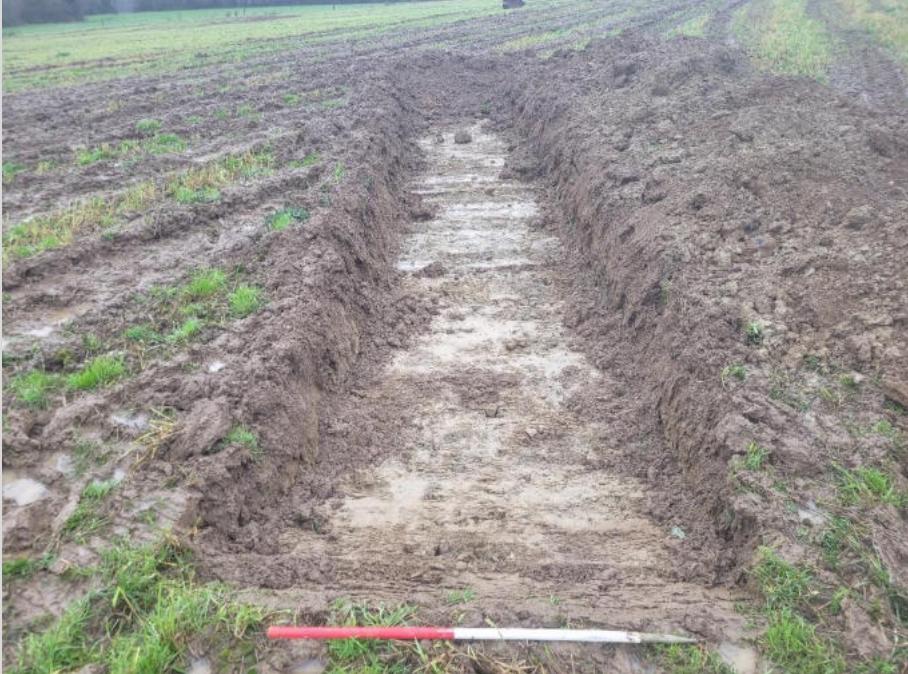
Trench Number	Length	Depth (m)	Archaeology Identified	Description
14	10m	0.8	No archaeological deposits identified	
				<p>Topsoil was removed directly onto subsoil which consisted of a brownish-orange silt clay. The linear feature [2], which was identified during the geophysical survey, was not visible in the trench.</p>

<p>Looking north</p>
Trench Number	Length	Depth (m)	Archaeology Identified	Description
15	10m	0.8	No archaeological deposits identified	
				<p>Topsoil was removed directly onto subsoil which consisted of a brownish-orange silt clay. The linear feature [2], which was identified during the geophysical survey, was not visible in the trench.</p>
