## ARCHAEOLOGICAL TESTING REPORT

<b>Report</b>	Archaeological testing report
<b>Project</b>	Derrygrogan Little Solar Farm
<b>Townlands</b>	Derrygrogan Little
<b>Parish</b>	Ballycommon
<b>Barony</b>	Lower Philipstown
<b>County</b>	Offaly
<b>Grid Ref</b>	ITM 640994, 729274
<b>Licence No</b>	25E0987
<b>Author</b>	Audrey Gahan
<b>Date</b>	19/12/2025

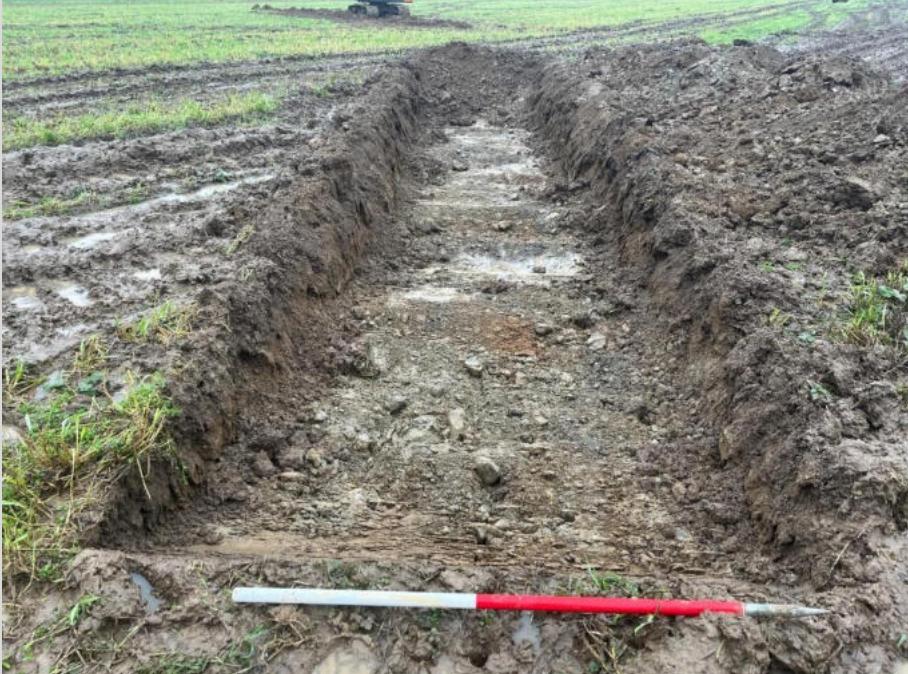
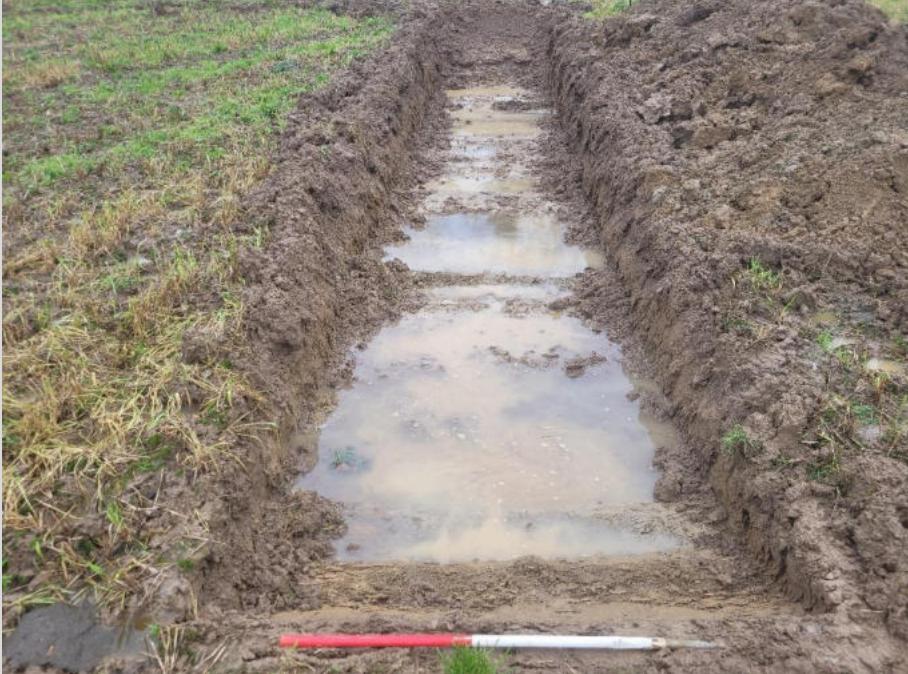
Trench Number	Length	Depth (m)	Archaeology Identified	Description
18	10m	0.4-0.5	No archaeological deposits identified

<i>Looking northeast</i>				Topsoil was removed directly onto subsoil which consisted of a mid-grey stoney silty clay. The linear feature [2], which was identified during the geophysical survey, was not visible in the trench.

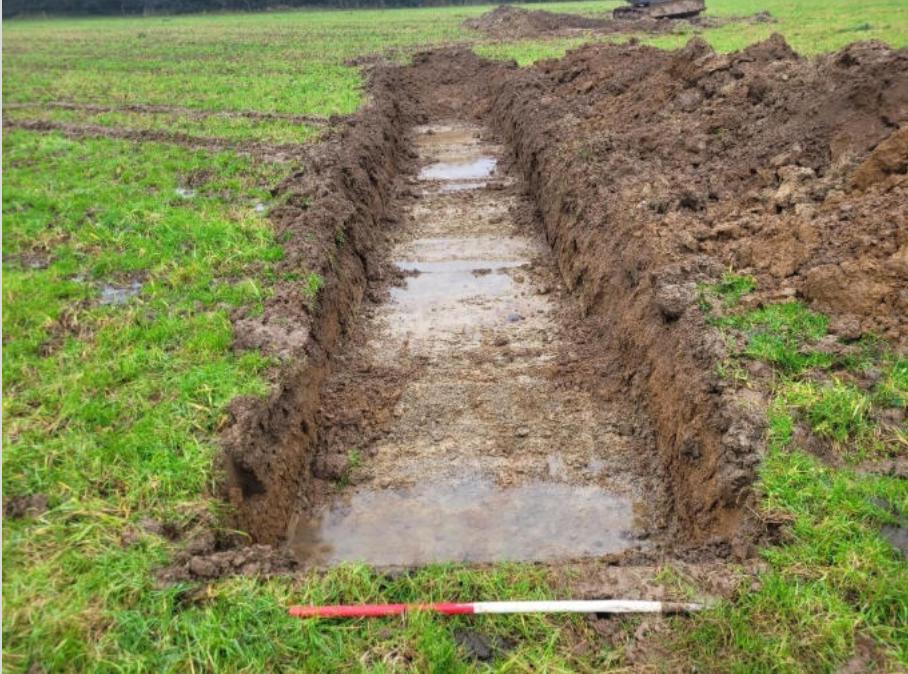
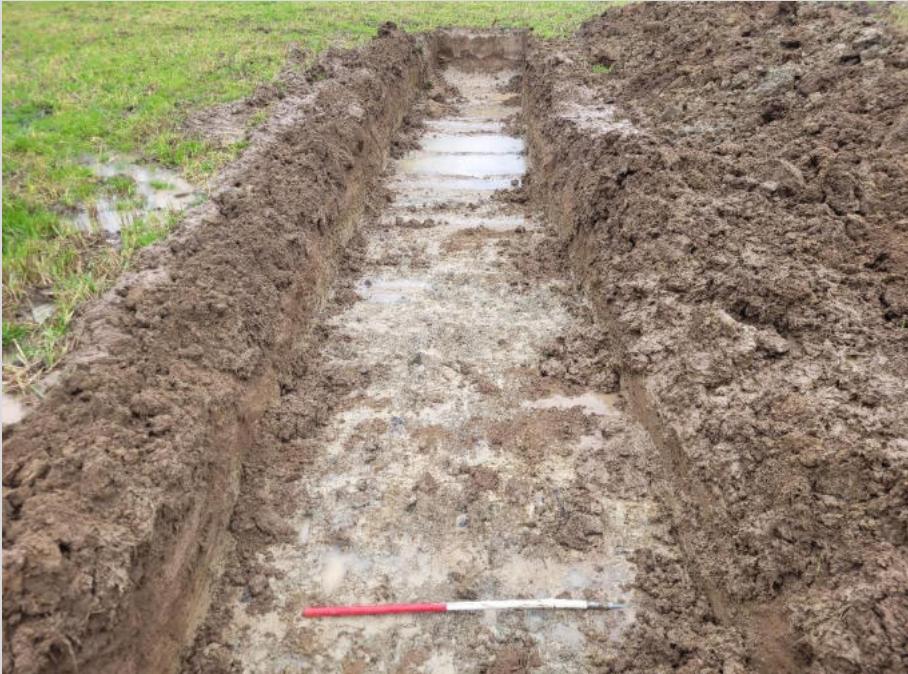
Trench Number	Length	Depth (m)	Archaeology Identified	Description
20	10m	0.4-0.5	No archaeological deposits identified	
				<p>Topsoil was removed directly onto subsoil which consisted of a brownish-orange silt clay. The linear feature [2], which was identified during the geophysical survey, was not visible in the trench.</p>

<p>Looking southeast</p>
Trench Number	Length	Depth (m)	Archaeology Identified	Description
21	10m	0.5-0.7	No archaeological deposits identified	
				<p>Topsoil was removed directly onto subsoil which consisted of a brownish-orange silt clay. The linear feature [2], which was identified during the geophysical survey, was not visible in the trench.</p>

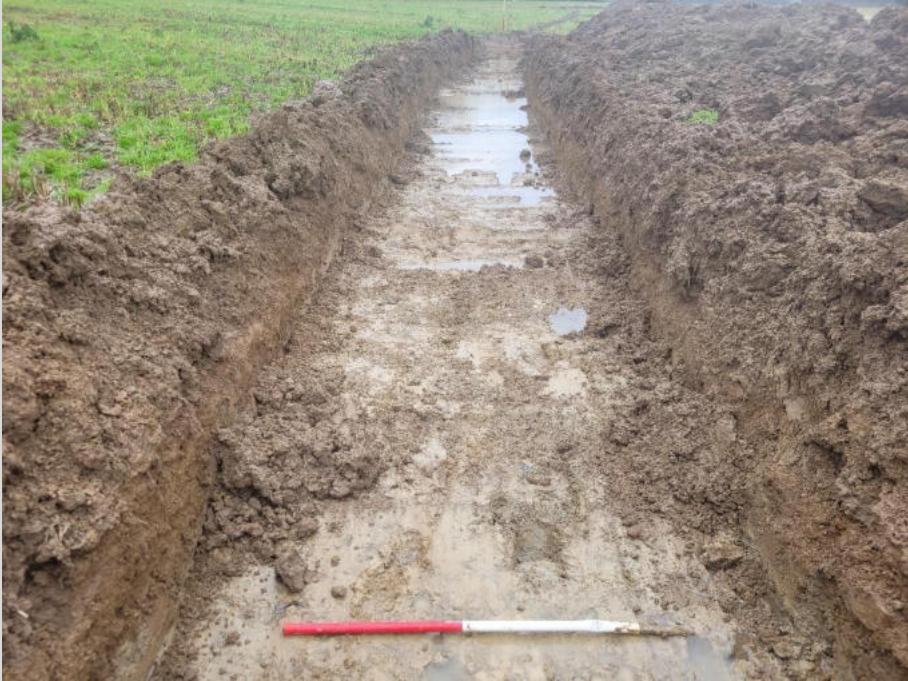
Trench Number	Length	Depth (m)	Archaeology Identified	Description
22	20m	0.5-0.6	Archaeological deposits identified

<p>Topsoil was removed directly onto subsoil which consisted of a brownish-orange silt clay.</p> <p>A linear feature was identified extending northeast-southwest across the western half of the trench.</p> <p>This feature is shown as [2] on the geophysical survey.</p>

Looking southeast

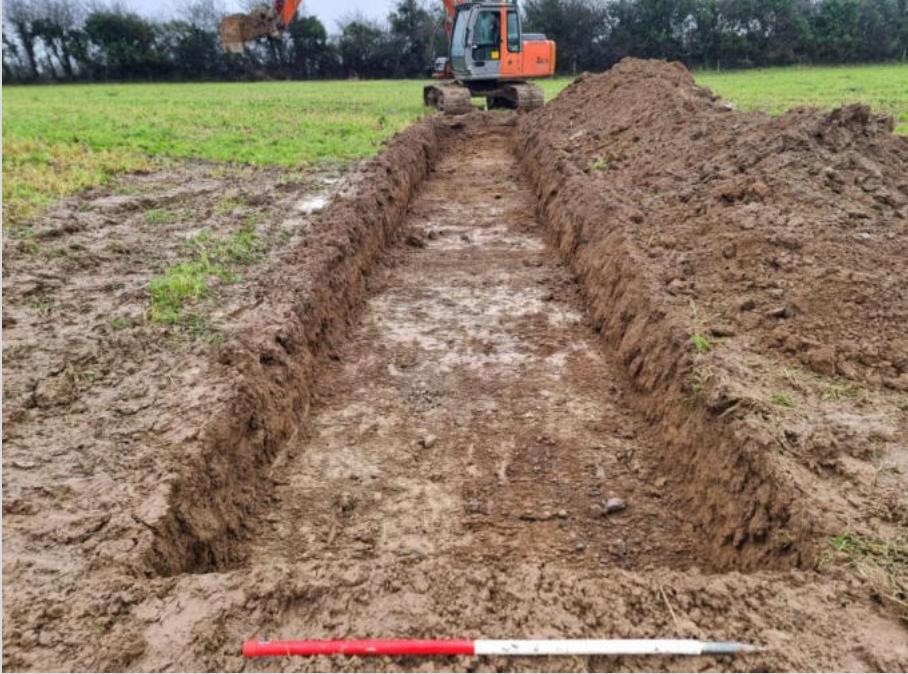
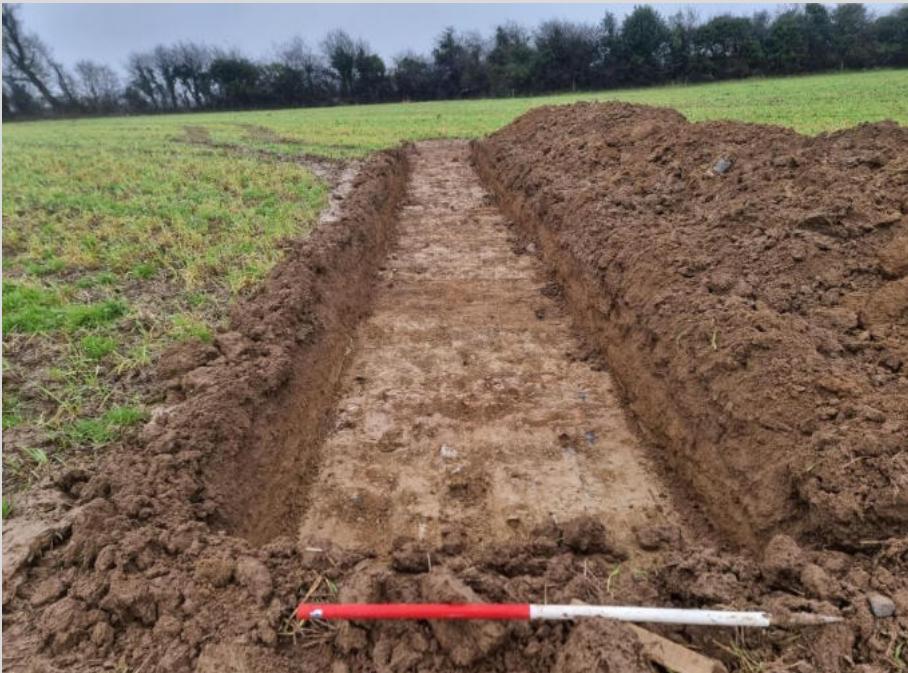
Trench Number	Length	Depth (m)	Archaeology Identified	Description
23	30m	0.45-0.6	No archaeological deposits identified

Topsoil was removed directly onto subsoil which consisted of a brownish-orange silt clay. A linear feature was identified extending northeast-southwest across the western half of the trench. This feature is shown as [2], which was identified during the geophysical survey, on the geophysical survey.

Eastern half of trench 23, looking southeast

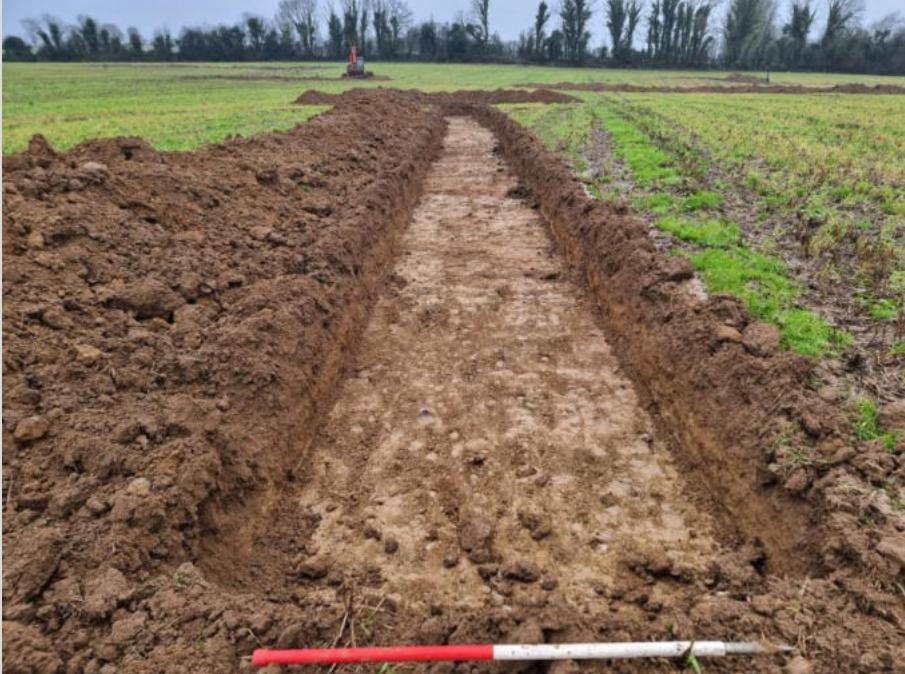
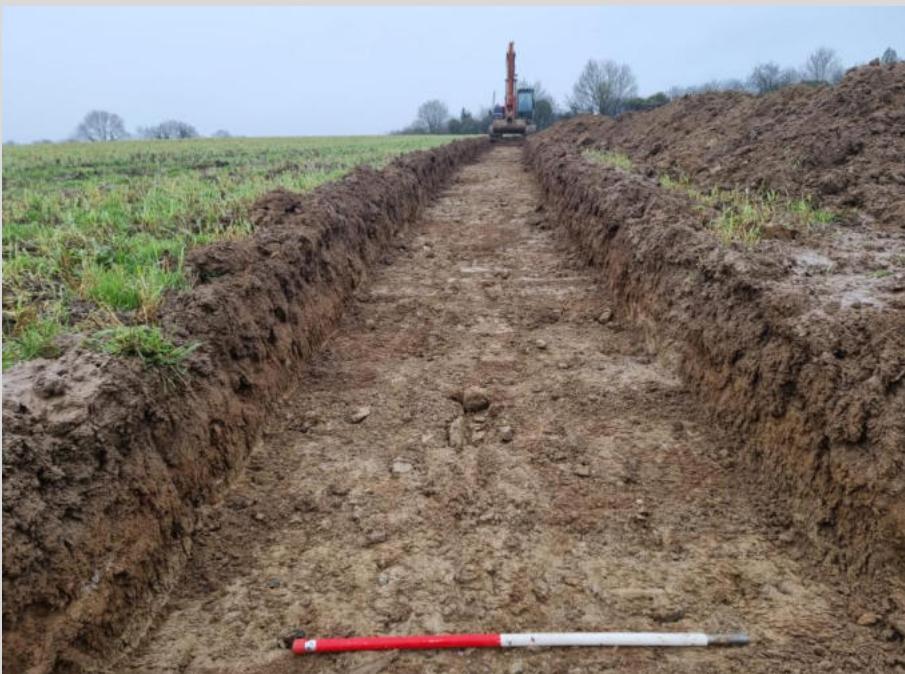
Trench Number	Length	Depth (m)	Archaeology Identified	Description
24	35m	0.7	No archaeological deposits identified

A photograph showing a long, narrow trench dug into the ground. The trench is flanked by high banks of brownish-orange silt clay. A red and white tape measure lies across the bottom of the trench for scale. In the background, a green field and a line of trees are visible under a clear sky.
				Topsoil was removed directly onto subsoil which consisted of a brownish-orange silt clay. The ditch feature [1], which was identified during the geophysical survey, was not visible in the trench.

A photograph showing the same trench from a different angle, looking towards the northeast. The red and white tape measure is again visible across the bottom of the trench. In the background, an orange excavator is working in the field. The trench walls are high and made of the same brownish-orange silt clay.

Looking southwest
				Looking northeast

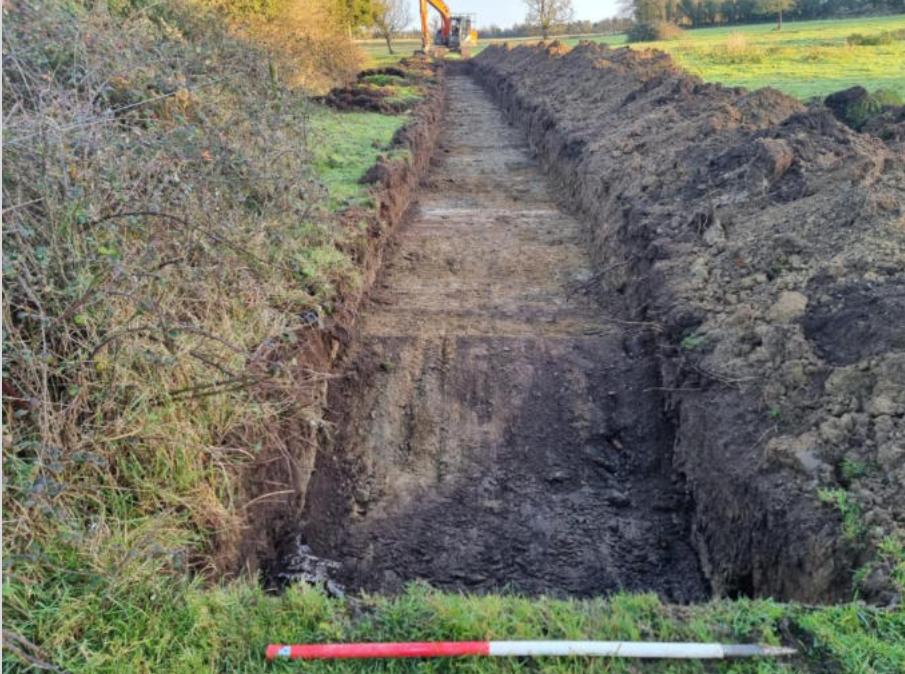
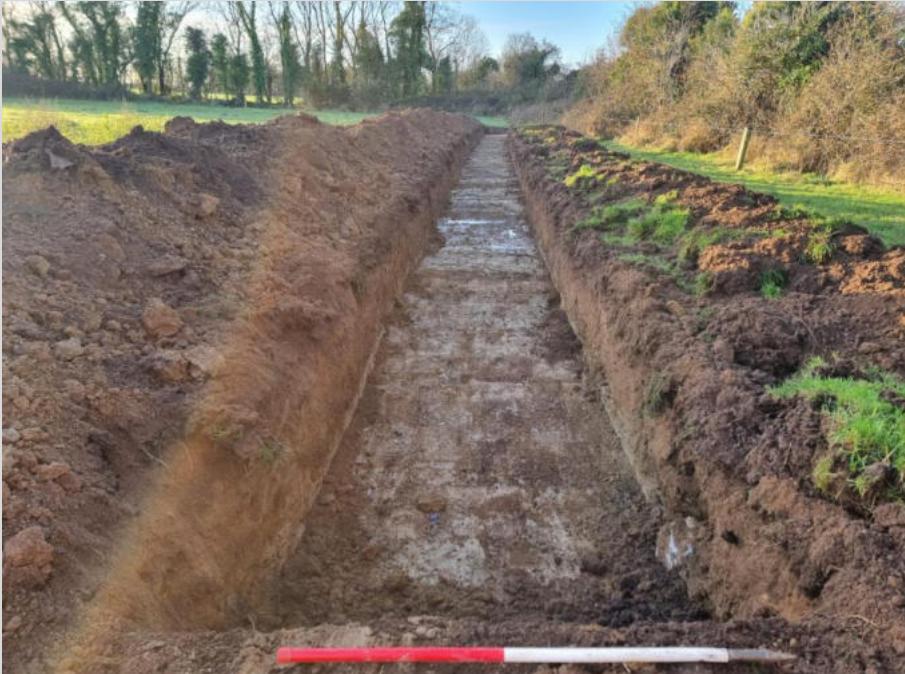
Trench Number	Length	Depth (m)	Archaeology Identified	Description
30	50m	0.5-1	No archaeological deposits identified

<p>For the most part, topsoil was removed onto subsoil which consisted of a brownish-orange silty clay. At the western end of the trench, there was a sheugh which corresponds to a field boundary on the early edition OS maps.</p>
				<p>Looking southeast</p>

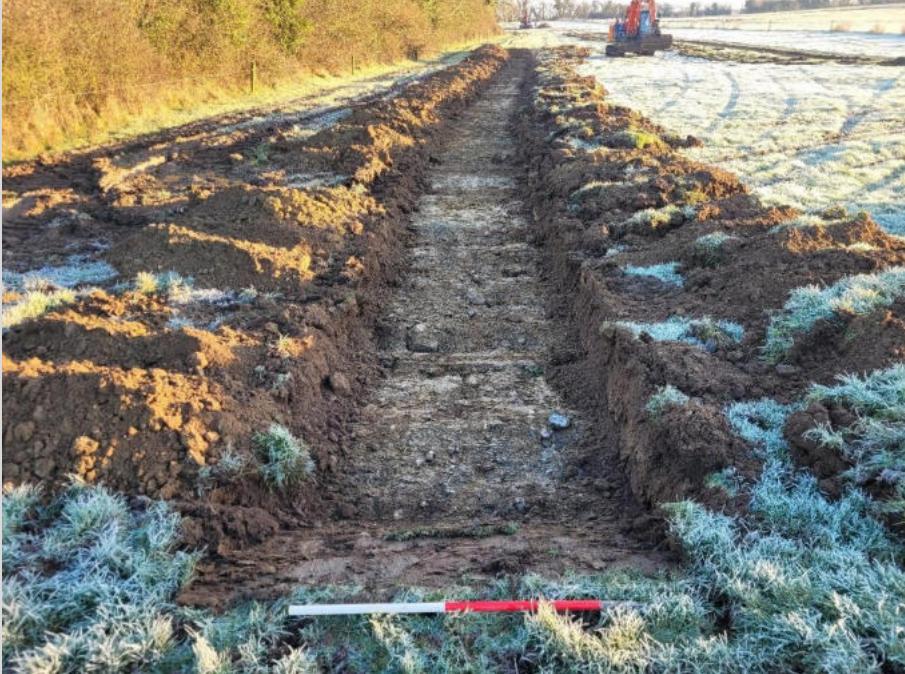
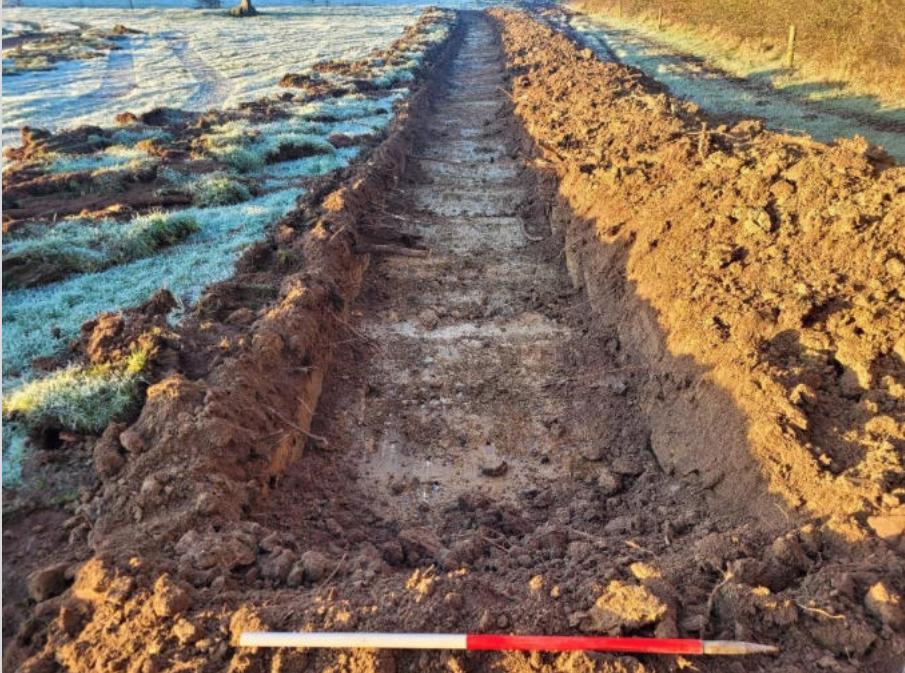
Trench Number	Length	Depth (m)	Archaeology Identified	Description			
31	60m	0.45	Archaeological deposits identified

<p>Topsoil was removed directly onto subsoil which consisted of a firm greyish-yellow silty clay. A linear feature [20] was identified extending north-south across the eastern half of the trench. The feature was identified during the geophysical survey and classified as a positive trend. The feature was also identified in trench 46.</p>

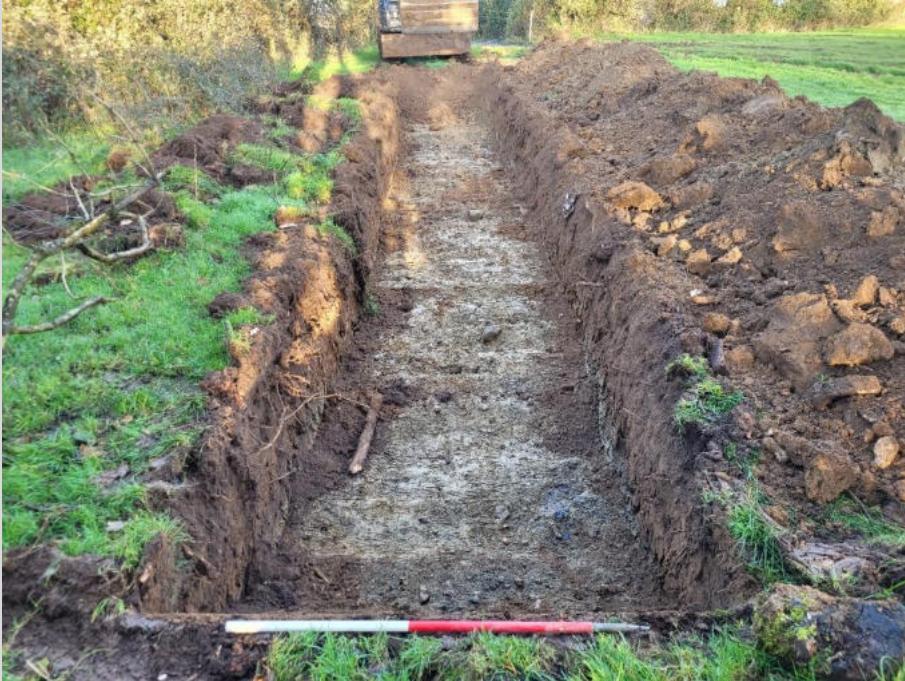
Trench Number	Length	Depth (m)	Archaeology Identified	Description
33	20m	0.8	No archaeological deposits identified

Topsoil was removed directly onto subsoil which consisted of a mid-grey stoney silty clay.

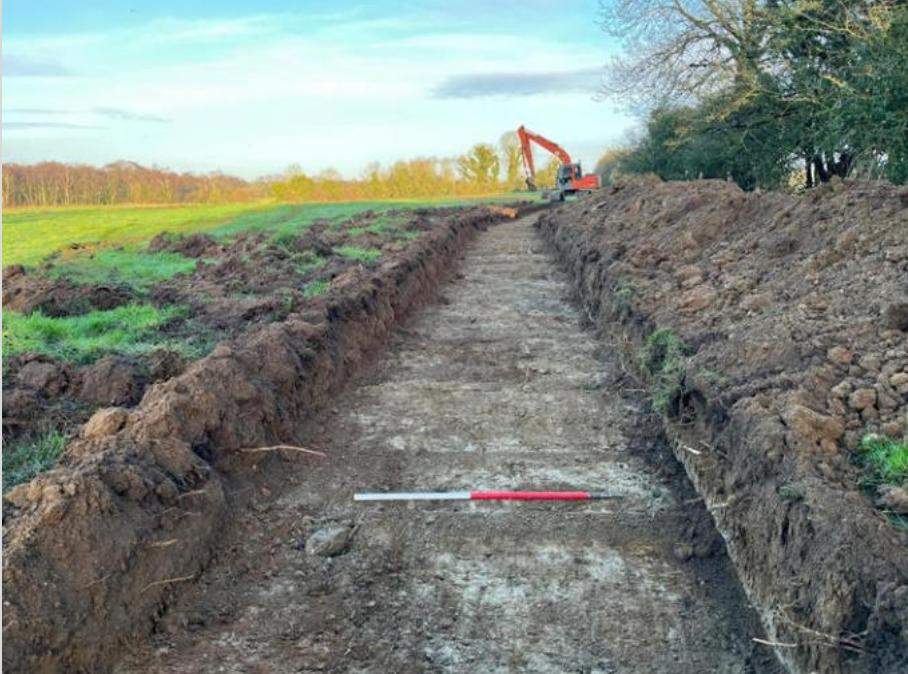
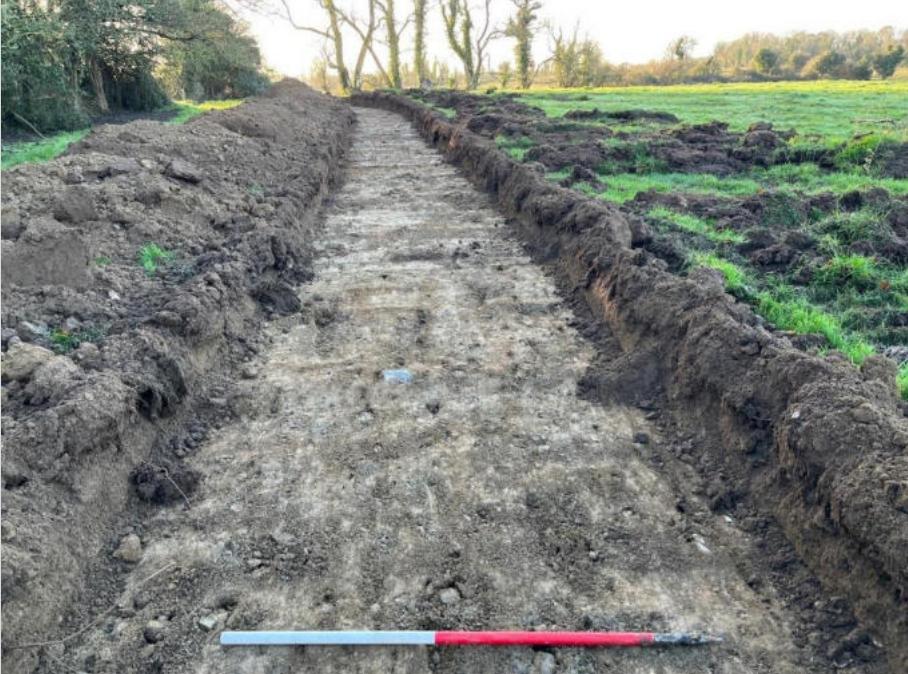
Trench Number	Length	Depth (m)	Archaeology Identified	Description			
34	60m	0.3-0.6	Archaeological deposits identified

<p>Topsoil was removed directly onto subsoil which consisted of a firm greyish-yellow silty clay. A linear feature [21] was identified extending east-west across the western half of the trench. The feature was not identified during the geophysical survey.</p>

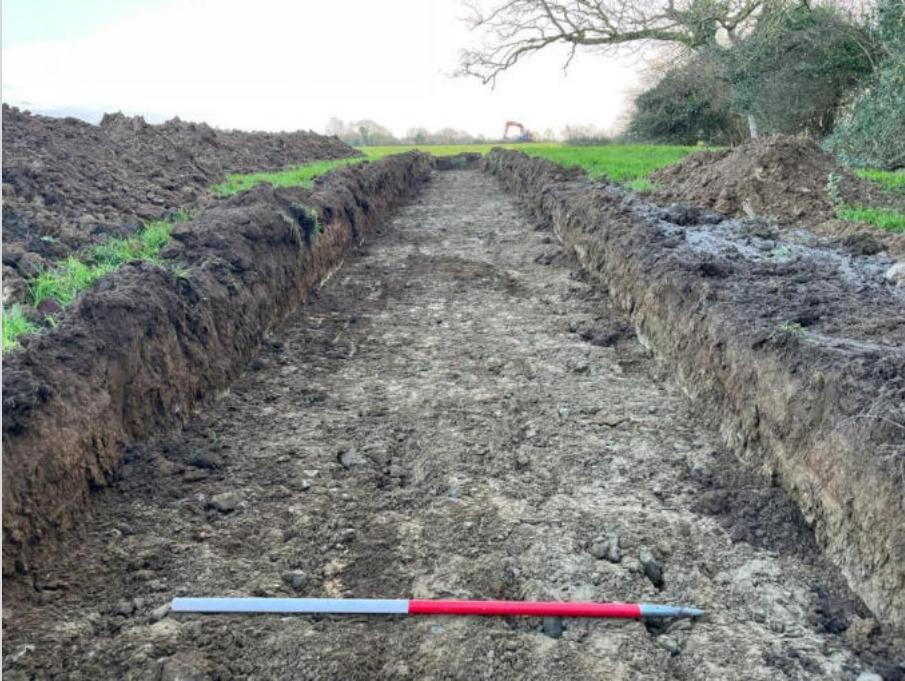
Trench Number	Length	Depth (m)	Archaeology Identified	Description
36	30m	0.4-0.5	No archaeological deposits identified

Topsoil was removed directly onto subsoil which consisted of a greyish yellow silty clay.

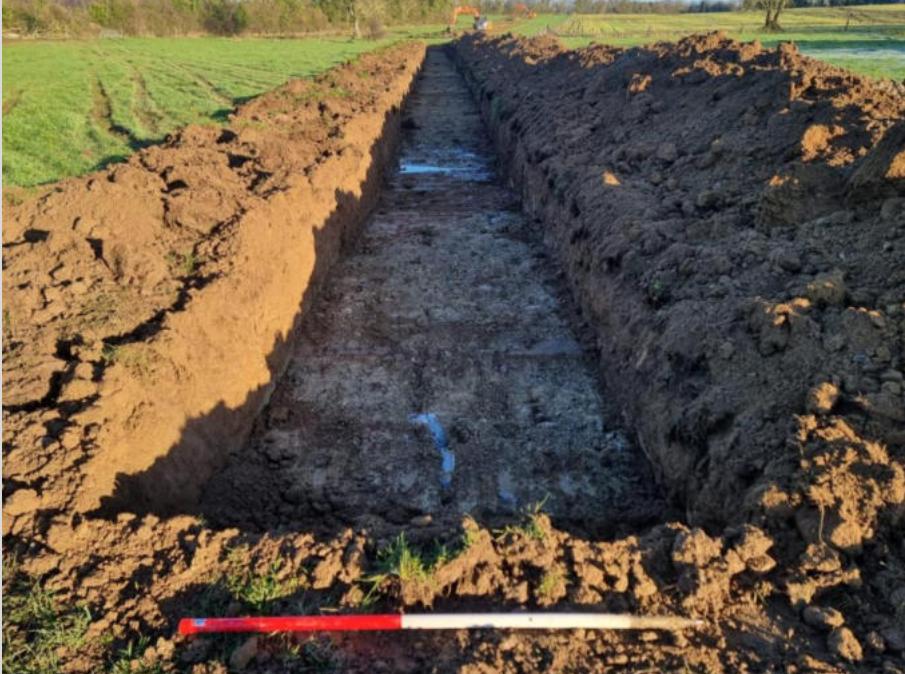
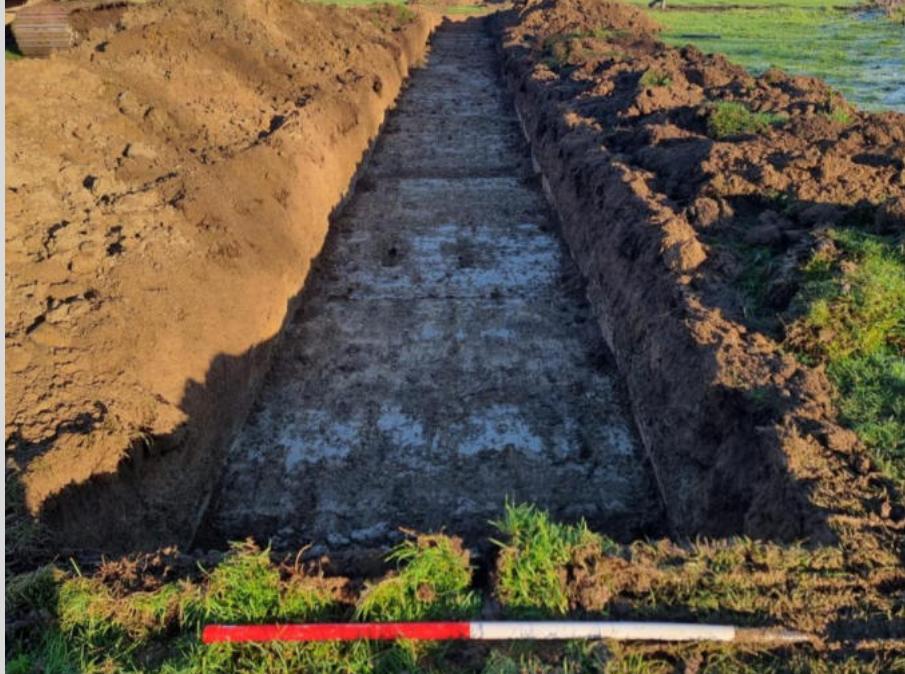
Trench Number	Length	Depth (m)	Archaeology Identified	Description
38	92m	0.6	No archaeological deposits identified

<p>Trench 38 was excavated in two parts to maintain access for the landowner across the site during the works. Topsoil was removed directly onto subsoil which varied between a firm greyish-yellow silty clay and a brownish-orange silty clay.</p>

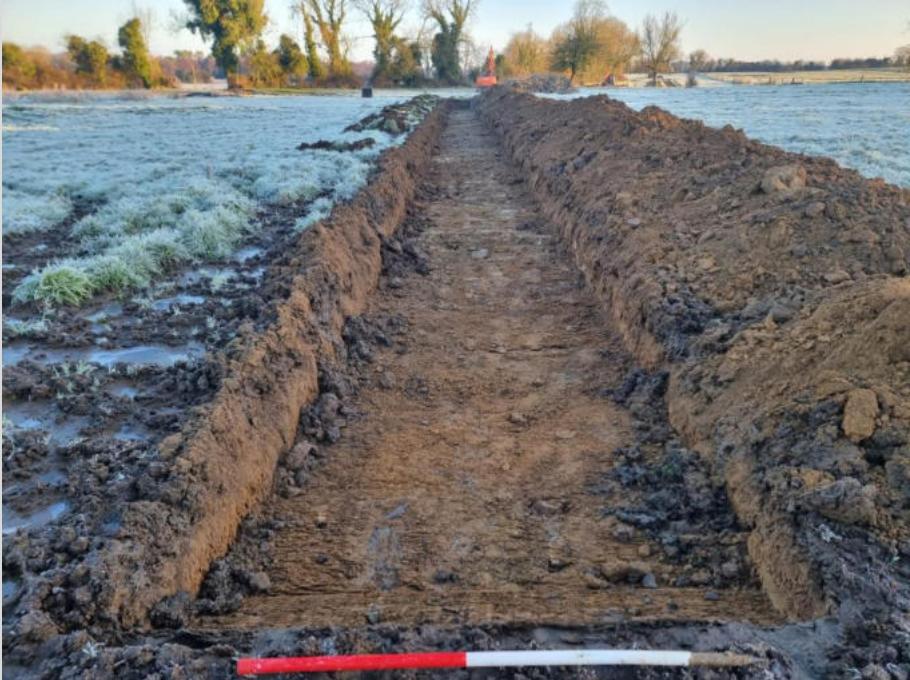
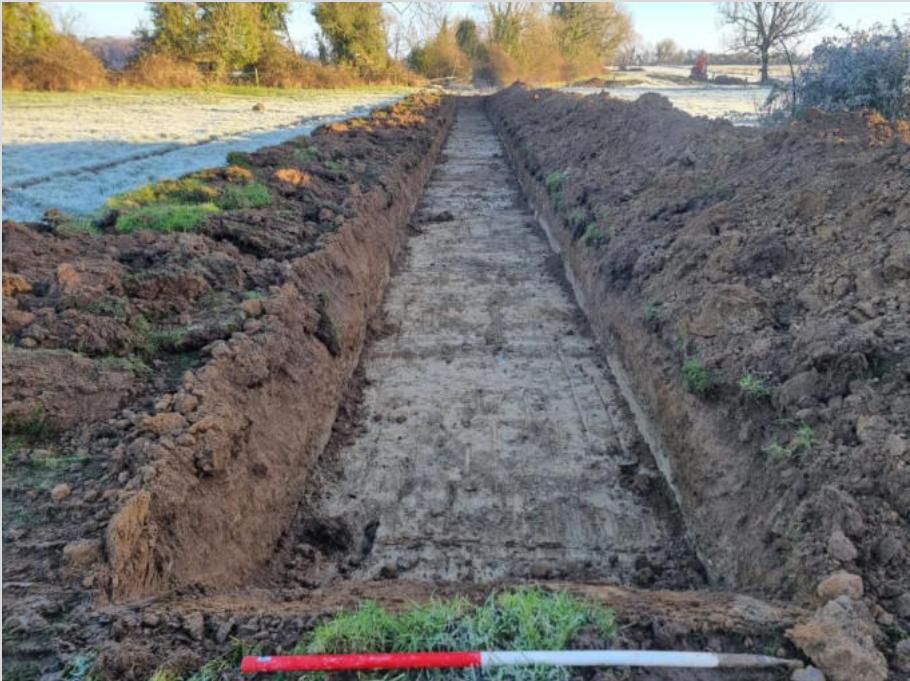
Trench Number	Length	Depth (m)	Archaeology Identified	Description
39	92m	0.5	No archaeological deposits identified

<p>Trench 39 was excavated in two parts to maintain access for the landowner across the site during the works. Topsoil was removed directly onto subsoil which varied between a firm greyish-yellow silty clay and a brownish-orange silty clay. A linear feature was identified extending east-west across the western half of the trench. The feature was not identified during the geophysical survey but a review of the early edition OS maps shows that this feature corresponds with the location of a field old boundary.</p>

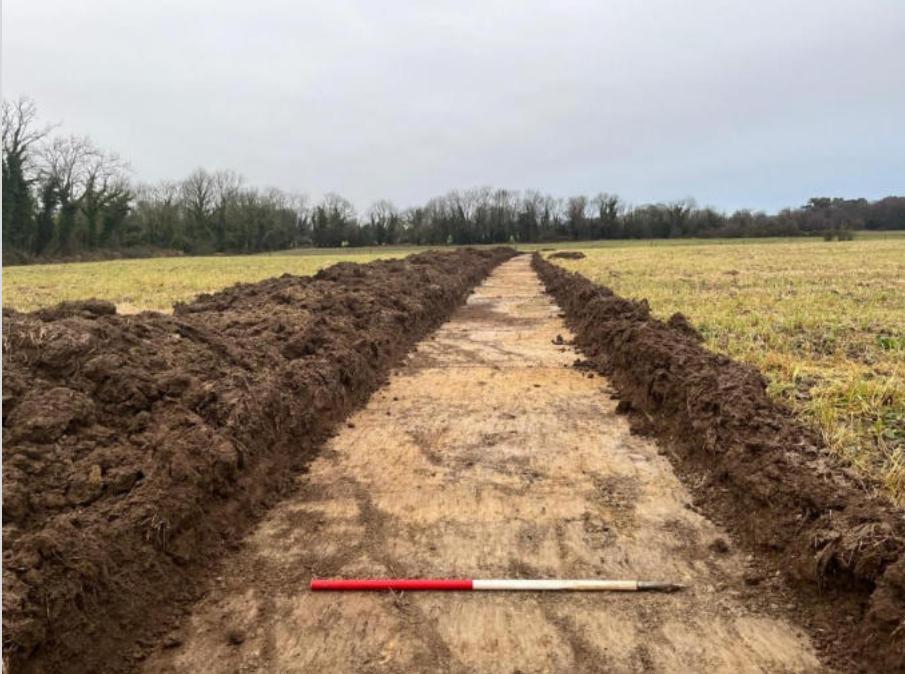
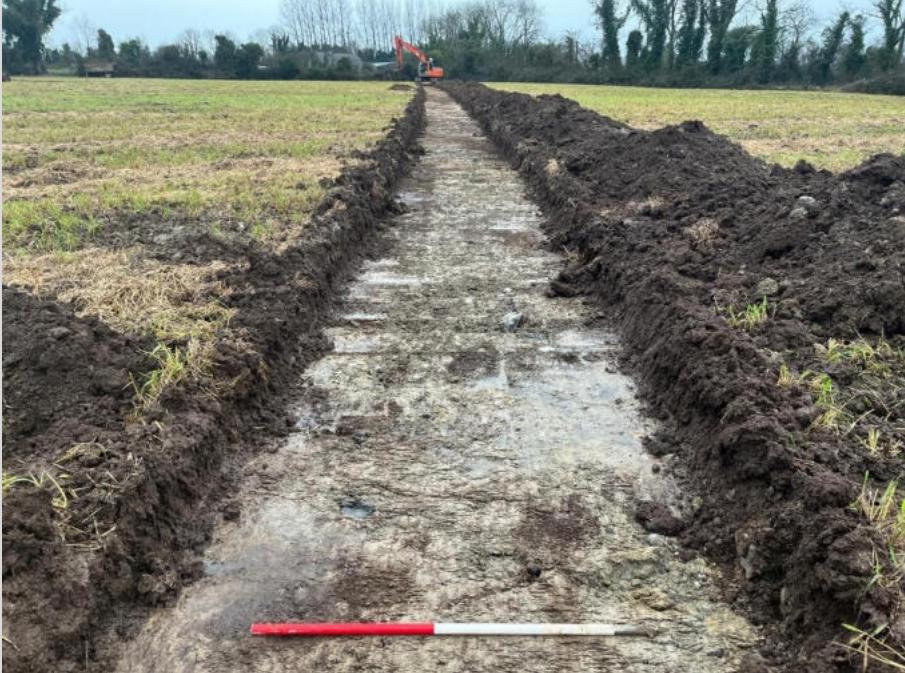
Trench Number	Length	Depth (m)	Archaeology Identified	Description
40	100m	0.3	No archaeological deposits identified

A photograph of a long, narrow trench dug into a field. The trench is flanked by high banks of dark brown soil. The bottom of the trench is a lighter-colored, textured earth. A red and white surveying pole lies across the bottom of the trench, providing a sense of scale. The background shows a flat, grassy field and a line of trees under a clear sky.
				Topsoil was removed directly onto subsoil which varied between a light grey stoney silty clay and a light brownish-orange silt clay. Plough marks are visible throughout the trench.
				Looking north

A photograph of the same trench from a different angle, looking towards the south. The trench is filled with water, reflecting the sky. The high banks of soil are visible on either side. A red and white surveying pole lies across the bottom of the water-filled trench. In the background, a small orange excavator is visible in the distance, and a line of trees marks the horizon.

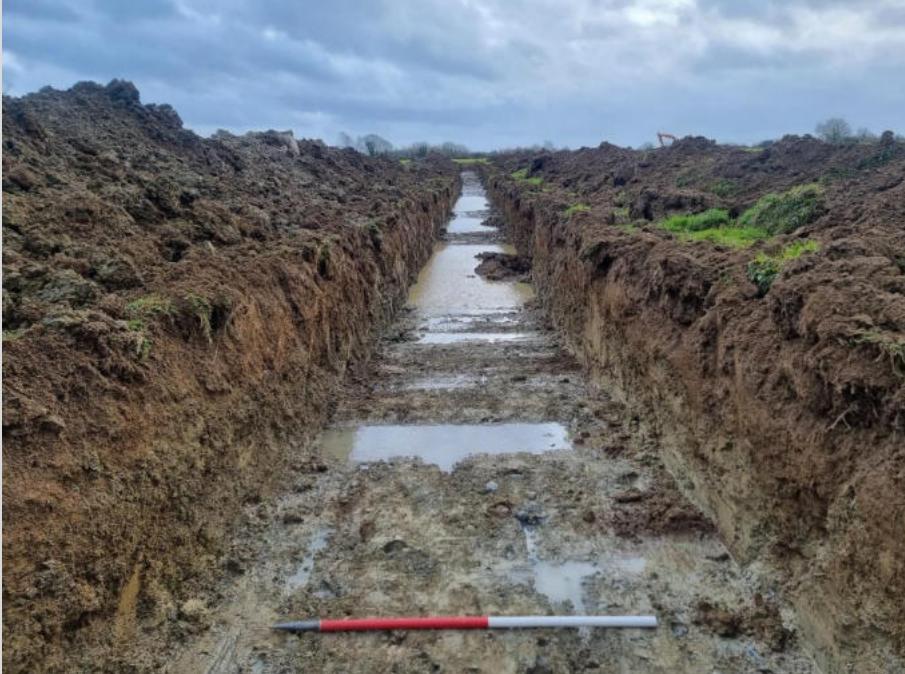
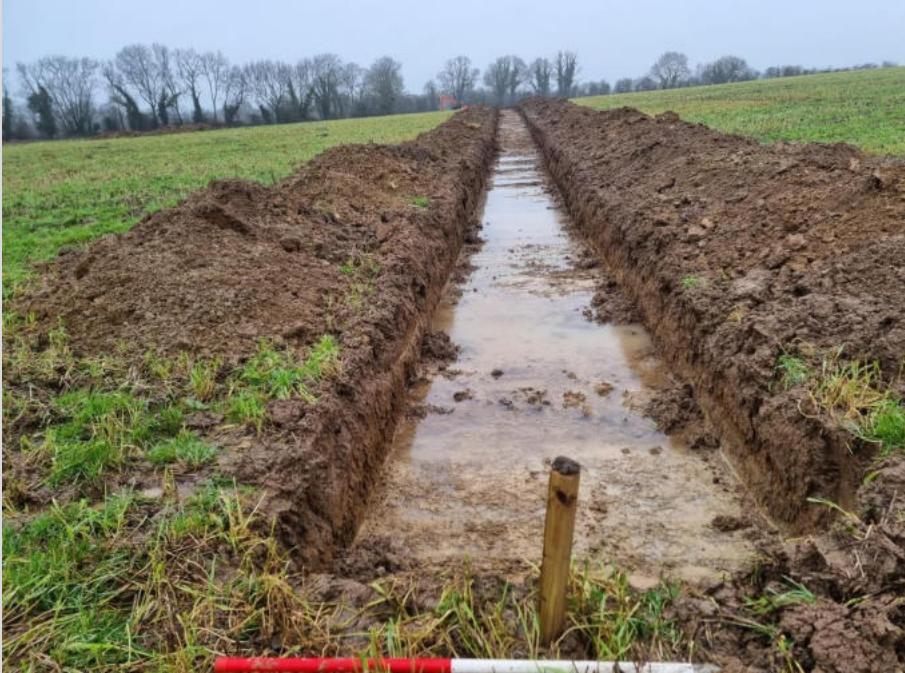
Trench Number	Length	Depth (m)	Archaeology Identified	Description
42	100m	0.4-0.6	Archaeological deposits identified

<p>Topsoil was removed directly onto subsoil which consisted of a brownish-orange silty clay.</p> <p>A roughly circular feature [22] was identified in the southern half of the trench. This feature was not identified during the geophysical survey.</p> <p>Displacement of groundwater following heavy rainfall resulted in this trench filling with water during the course of excavation.</p>

Trench No.	Feature No	Description	Mitigation
42	22	Charcoal rich circular pit- high archaeological significance	Solar arrays to be erected on supports with concrete feet within area shown on figure 13. All cabling to be above ground.
62	23	Burnt mound- high archaeological significance	Solar arrays to be erected on supports with concrete feet within area shown on figure 13. All cabling to be above ground.

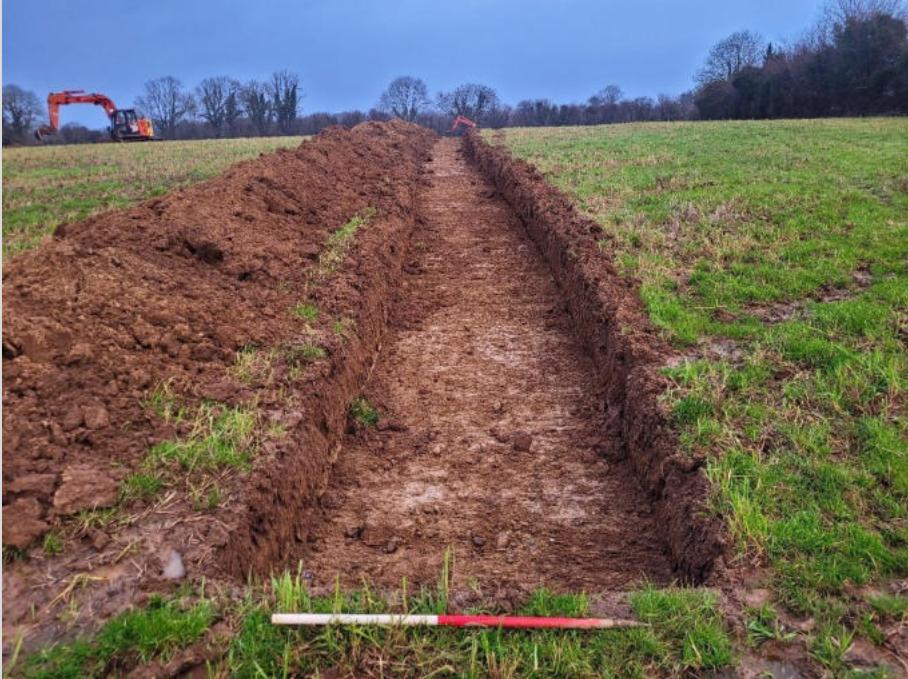
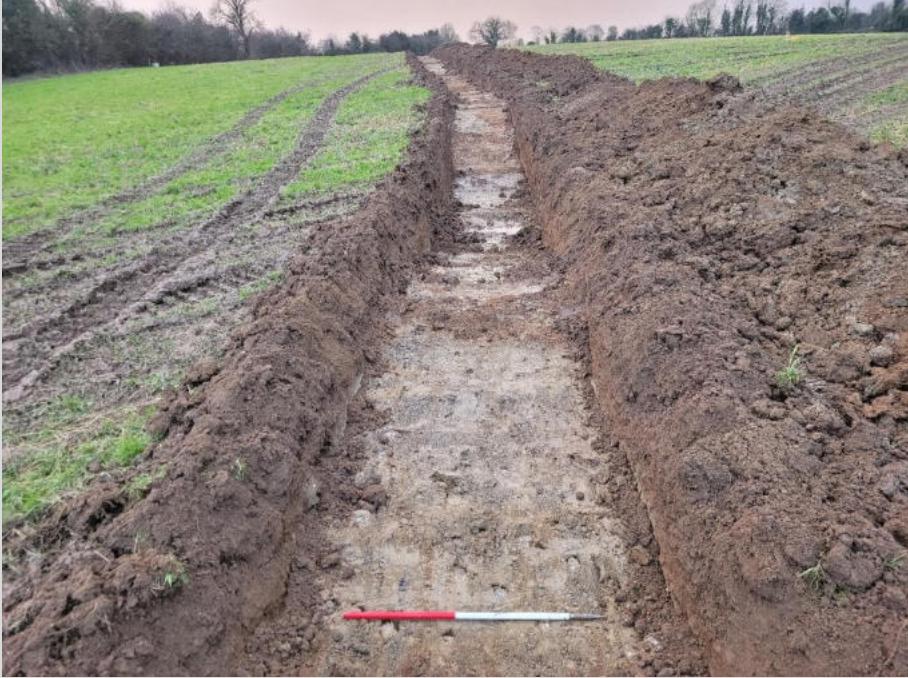
Trench Number	Length	Depth (m)	Archaeology Identified	Description
43	100m	0.4-0.9	No archaeological deposits identified

Topsoil was removed directly onto subsoil which varied between a light grey stoney silty clay and a light brownish-orange silt clay. At the northwest end of the trench, material was removed to a depth of 0.9m. This corresponds to the geophysical survey, which identified this area as a possible quarry site. The field boundary [13] was not identified.

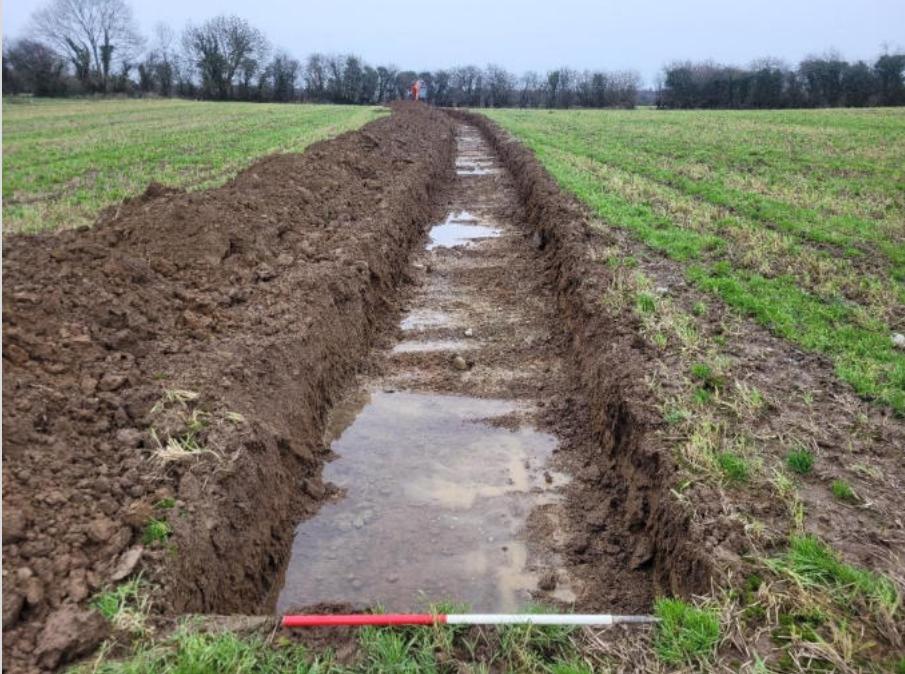
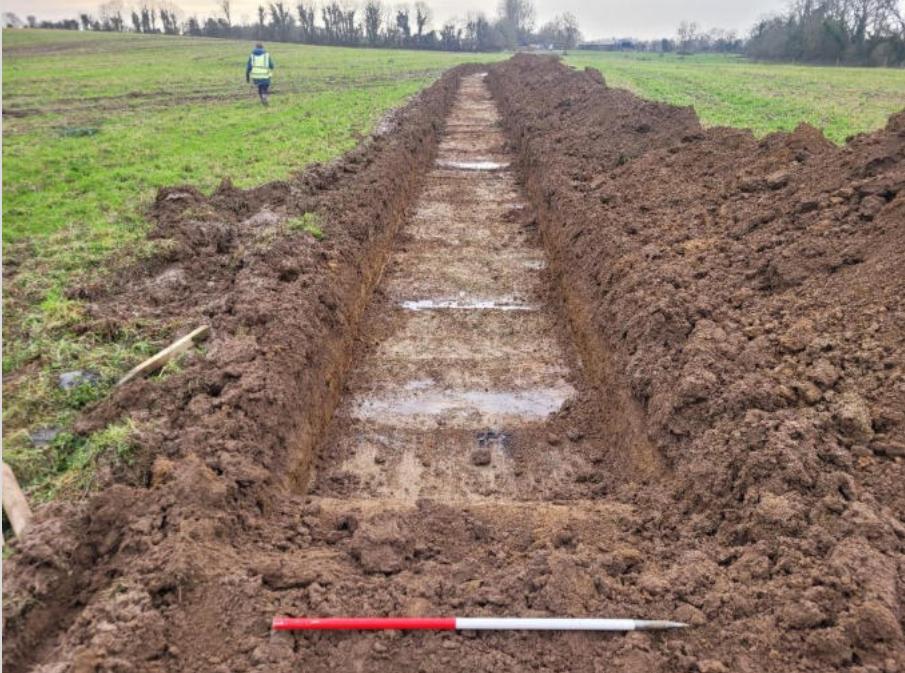
Trench Number	Length	Depth (m)	Archaeology Identified	Description
44	100m	0.4	No archaeological deposits identified

Topsoil was removed directly onto subsoil which consisted of a light brownish-orange silt clay.

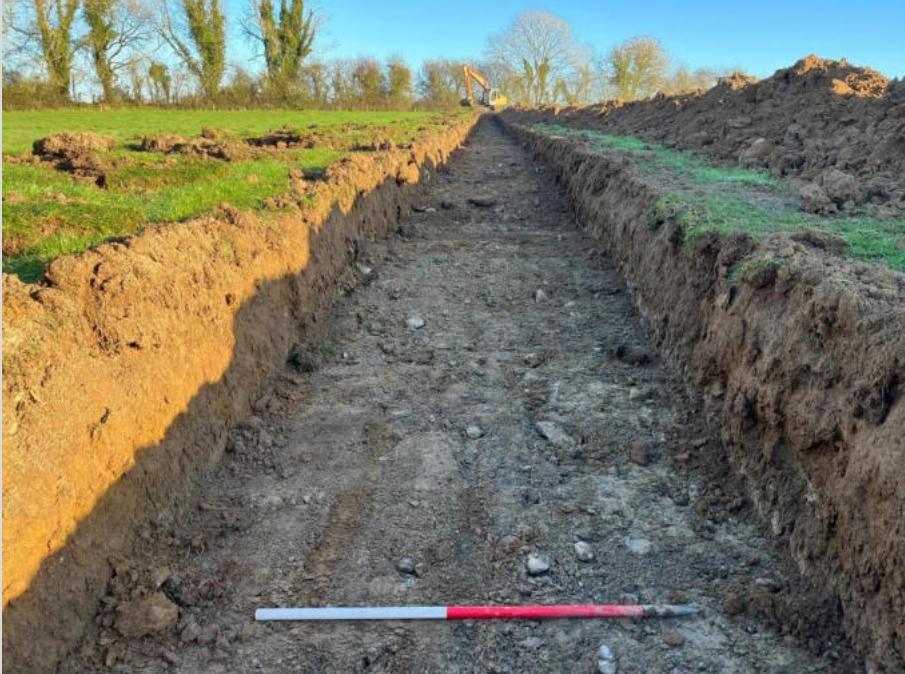
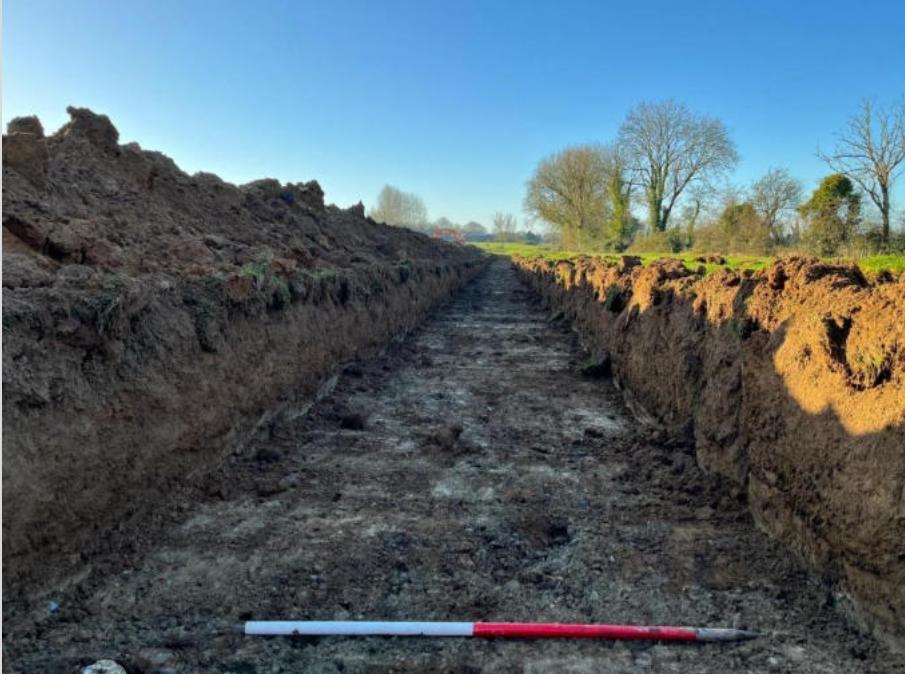
Trench Number	Length	Depth (m)	Archaeology Identified	Description			
45	100m	0.45-0.7	No archaeological deposits identified

<p>Topsoil was removed directly onto subsoil which consisted of light grey stoney silty clay. Plough marks are visible throughout the trench.</p>

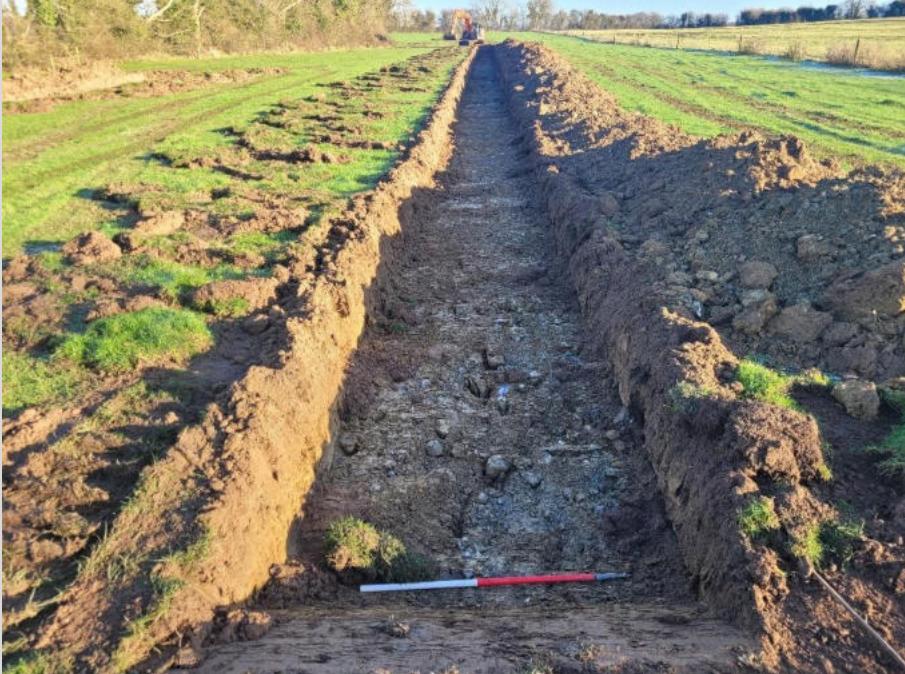
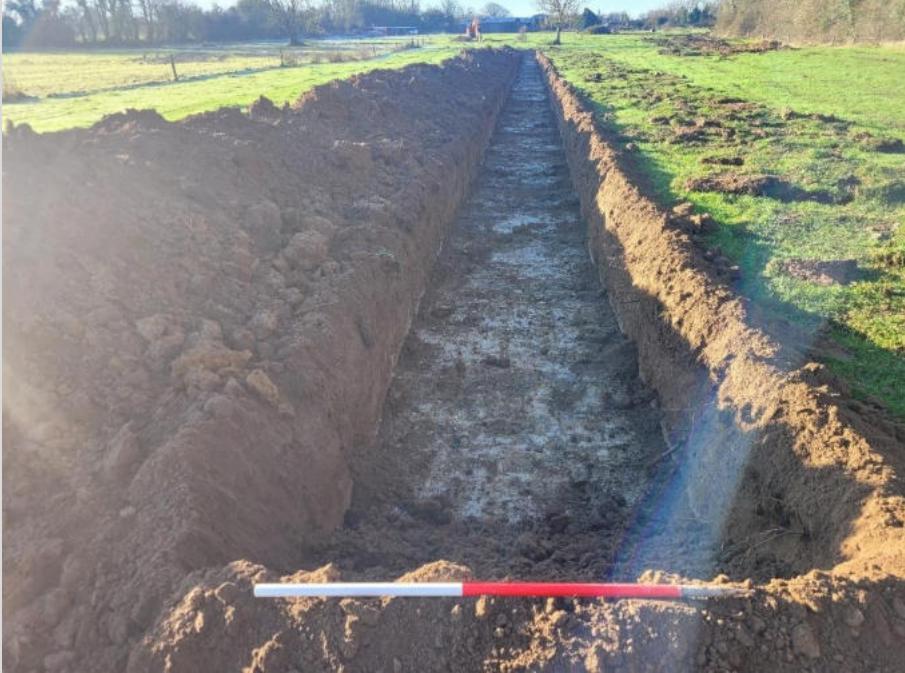
Trench Number	Length	Depth (m)	Archaeology Identified	Description			
46	100m	0.45	Archaeological deposits identified

<p>Topsoil was removed directly onto subsoil which consisted of a firm greyish-yellow silty clay. A linear feature [20] was identified extending north-south across the western half of the trench. The feature was identified during the geophysical survey and classified as a positive trend. The feature was also identified in trench 31.</p>
