## ARCHAEOLOGICAL TESTING REPORT

<b>Report</b>	Archaeological testing report
<b>Project</b>	Derrygrogan Little Solar Farm
<b>Townlands</b>	Derrygrogan Little
<b>Parish</b>	Ballycommon
<b>Barony</b>	Lower Philipstown
<b>County</b>	Offaly
<b>Grid Ref</b>	ITM 640994, 729274
<b>Licence No</b>	25E0987
<b>Author</b>	Audrey Gahan
<b>Date</b>	19/12/2025

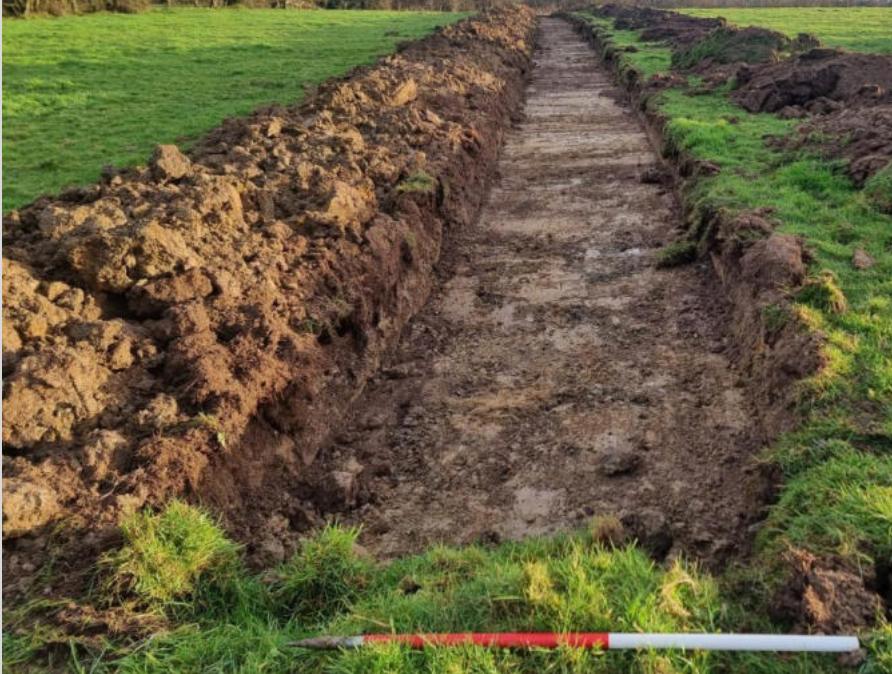
Trench Number	Length	Depth (m)	Archaeology Identified	Description
47	100m	0.3-0.4	No archaeological deposits identified

Topsoil was removed directly onto subsoil which consisted of a brownish-orange silty clay with occasional stone inclusions.

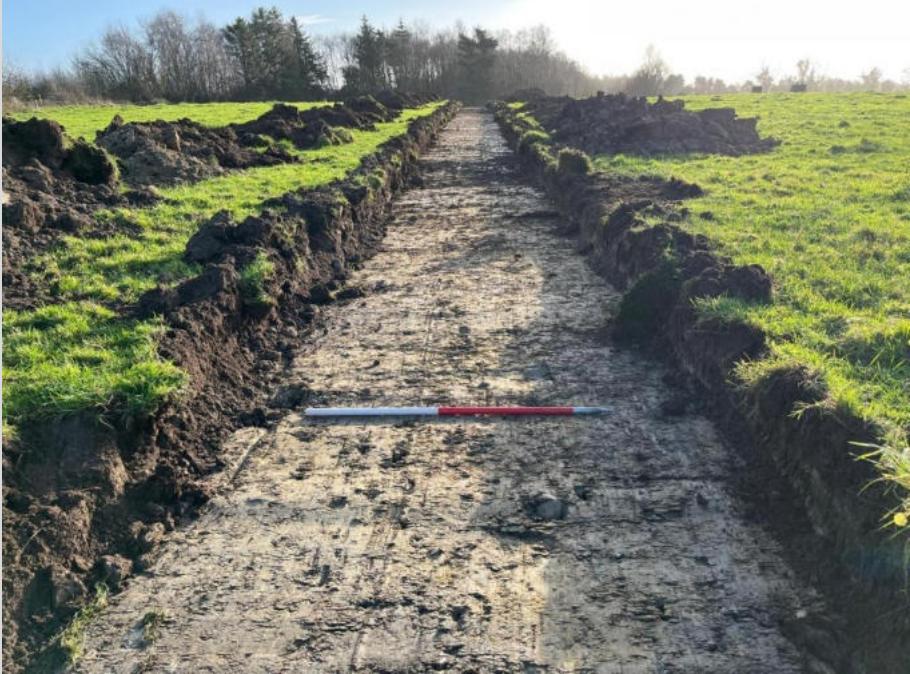
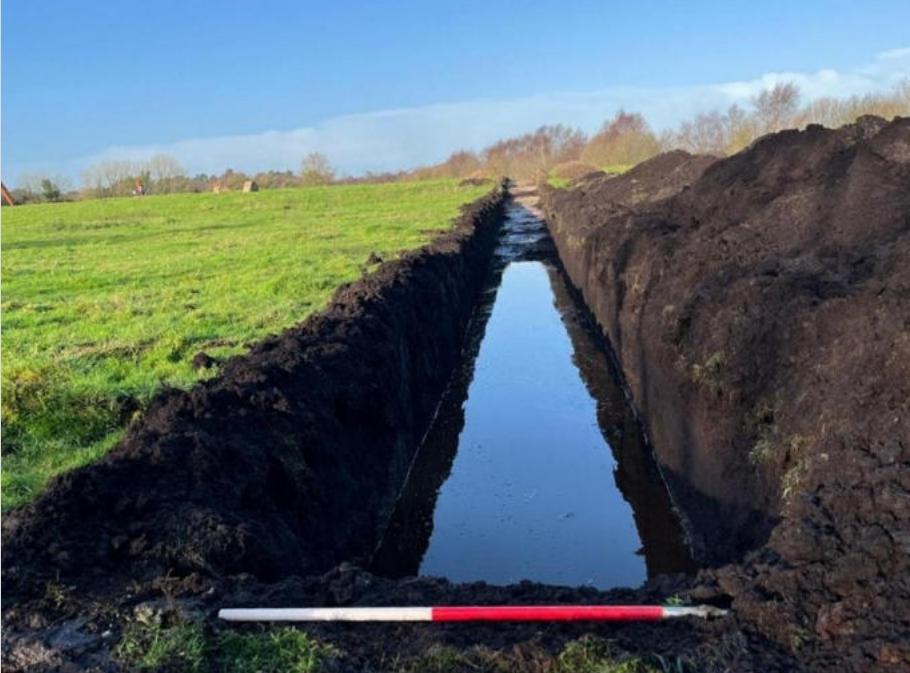
Trench Number	Length	Depth (m)	Archaeology Identified	Description
48	100m	0.4-1.6	No archaeological deposits identified

<p>Topsoil was removed directly onto subsoil in the northern half of the trench. In the southern end of the trench, subsoil was overlaid by a dark brownish black humic silty clay. Subsoil varied between a greyish-yellow silty clay and a light grey silty clay. A linear feature, consisting of a dark brownish black humic silty clay with roots throughout, was visible in the southern end of the trench. The feature represents the field boundary shown on the early edition OS maps.</p> <p>The ground was extremely waterlogged in this area and displacement of groundwater resulted in this trench filling with water during the course of excavation</p>

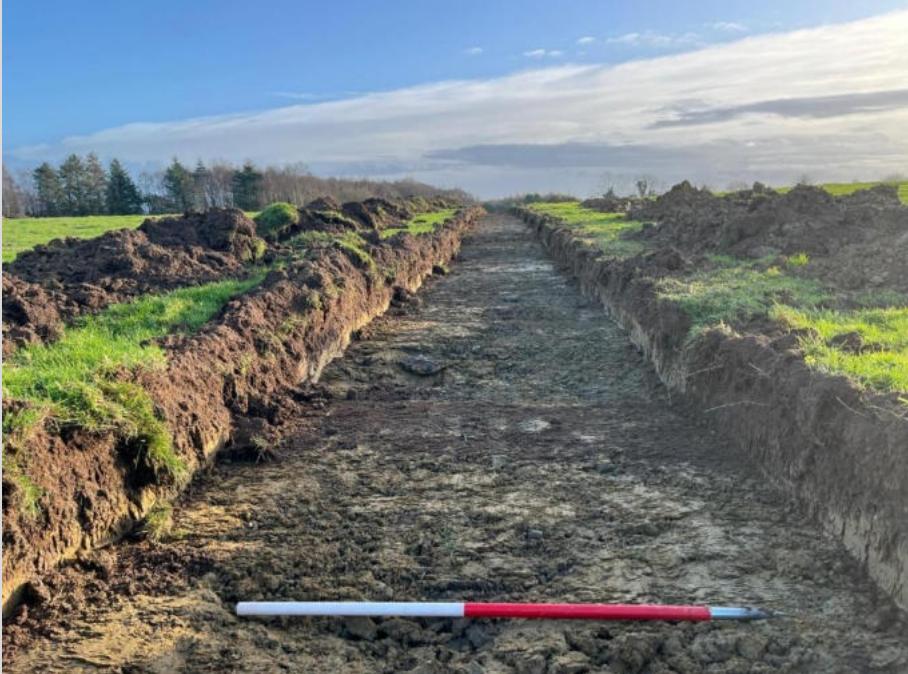
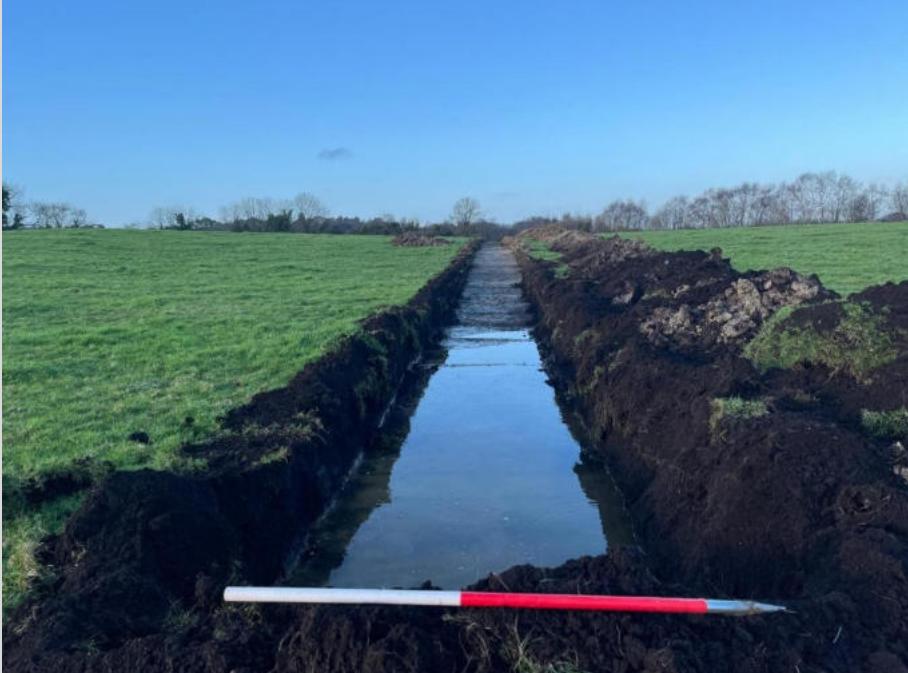
Trench Number	Length	Depth (m)	Archaeology Identified	Description
49	100m	0.4-0.7	No archaeological deposits identified

Looking southeast				Topsoil was removed directly onto subsoil in the northern half of the trench. In the southern end of the trench, subsoil was overlaid by a dark brownish black humic silty clay. Subsoil varied between a greyish-yellow silty clay and a light grey silty clay. The ground was extremely waterlogged in this area and displacement of groundwater resulted in this trench filling with water during the course of excavation

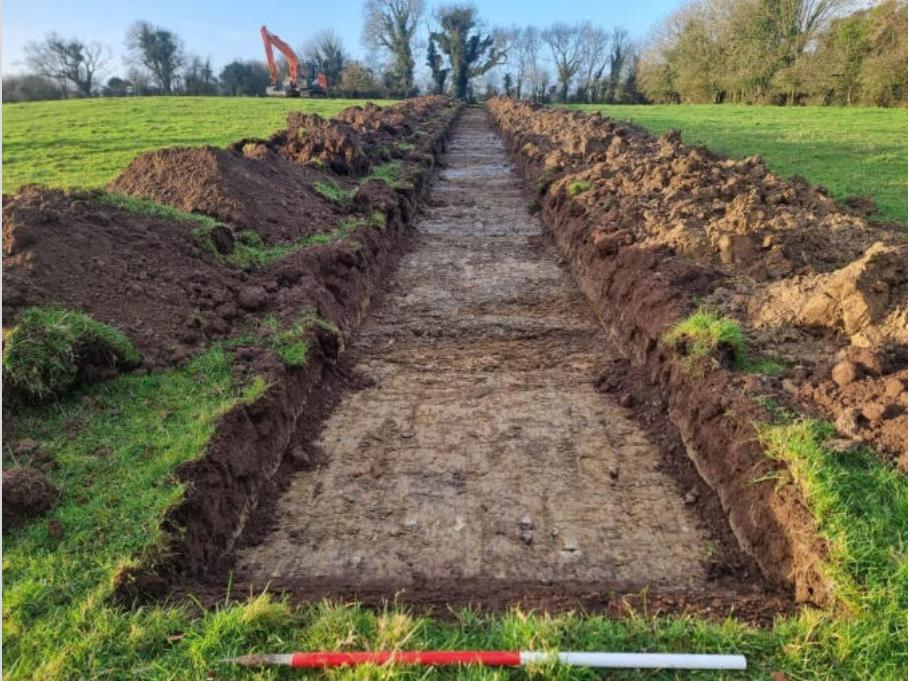
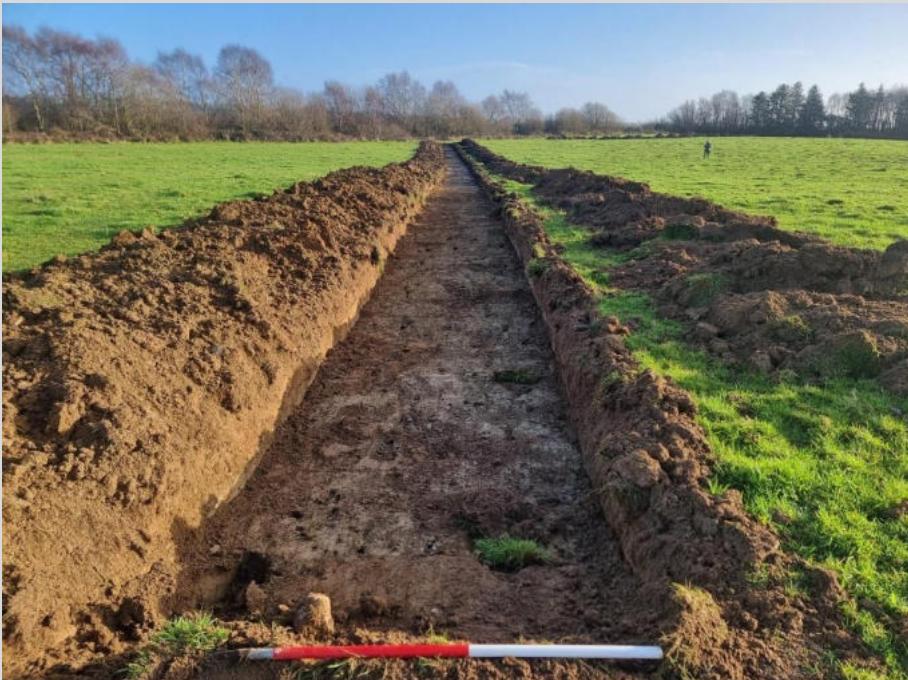
Trench Number	Length	Depth (m)	Archaeology Identified	Description
50	100m	0.4-0.5	No archaeological deposits identified

Topsoil was removed directly onto subsoil which consisted of brownish-orange silty clay.

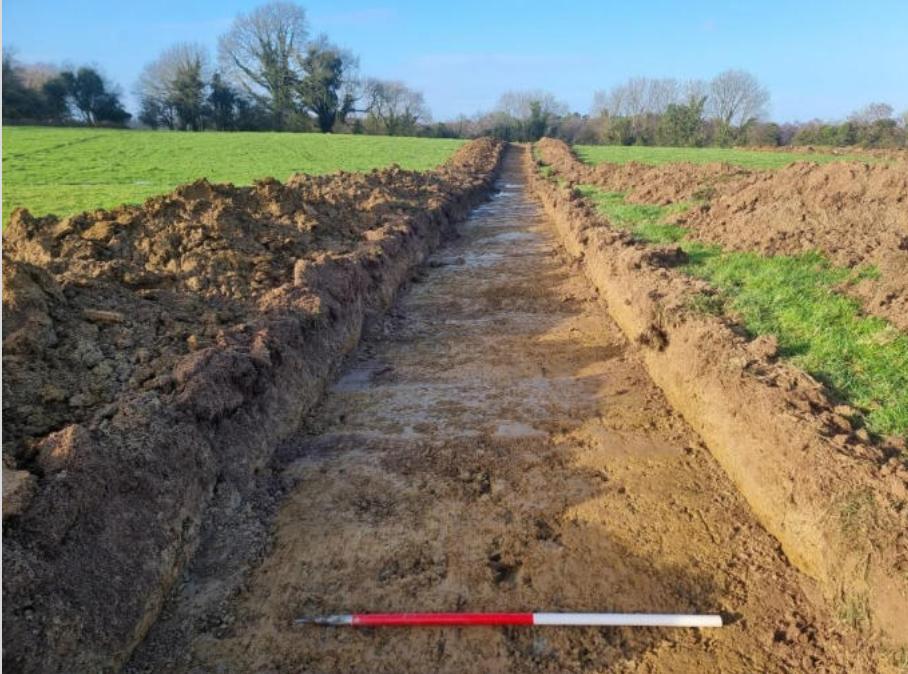
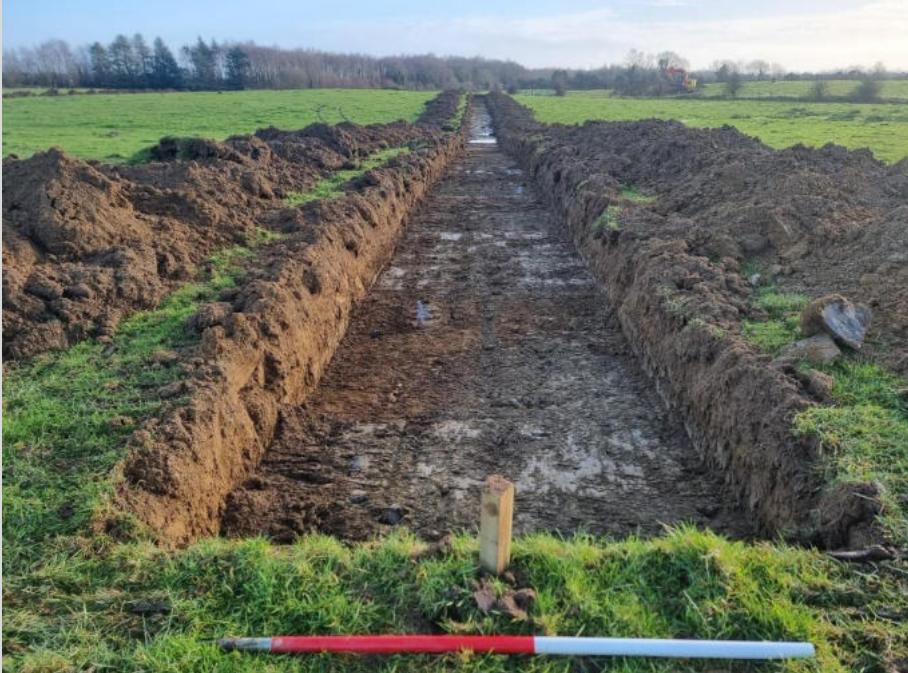
Trench Number	Length	Depth (m)	Archaeology Identified	Description			
51	100m	0.3-0.5	No archaeological deposits identified

<p>Topsoil was removed directly onto subsoil which consisted of brownish-orange silty clay.</p>

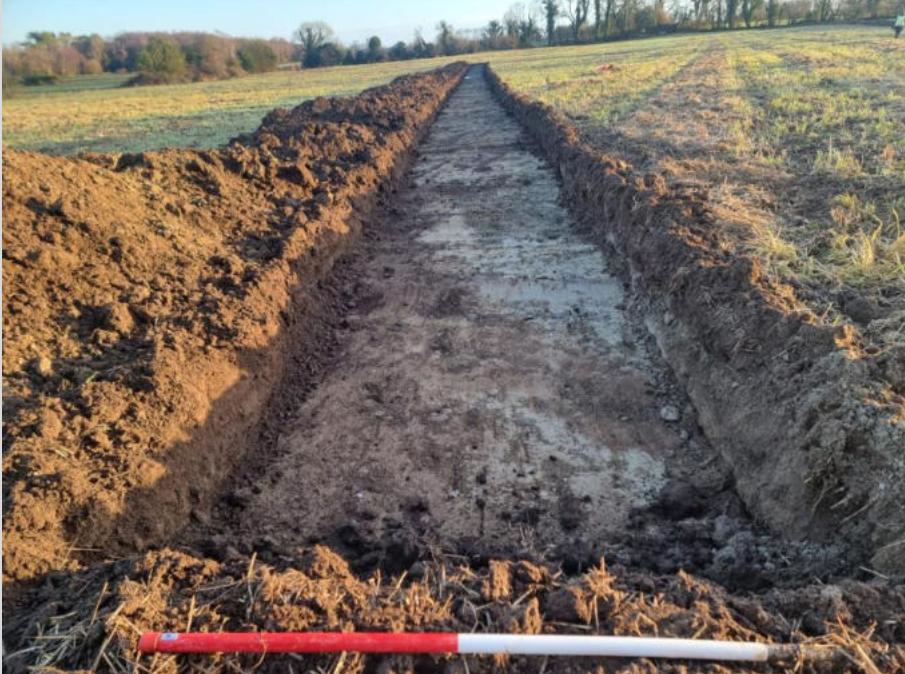
Trench Number	Length	Depth (m)	Archaeology Identified	Description
52	100m	0.4	No archaeological deposits identified	Topsoil was removed directly onto subsoil which varied between a light grey stoney silty clay and a light brownish-orange silt clay. A field boundary, numbered as [9] on the geophysical survey, extended north-south across the trench.

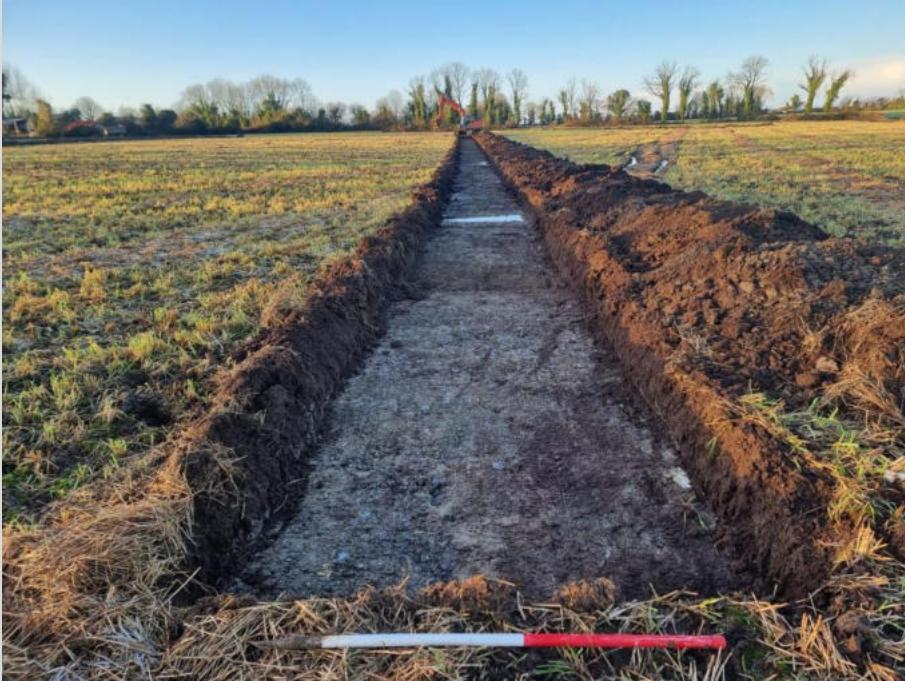
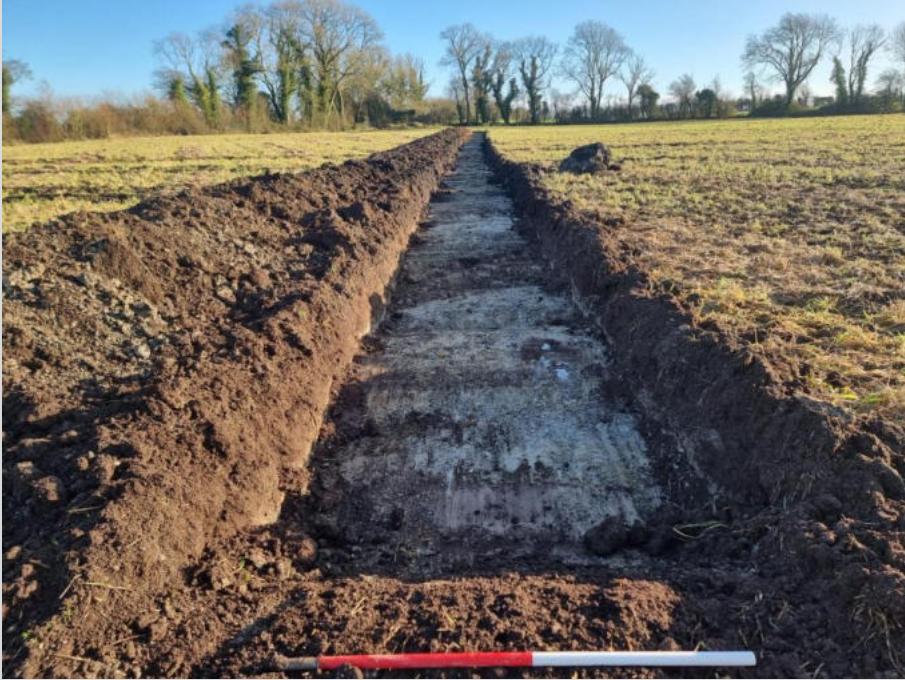
Trench Number	Length	Depth (m)	Archaeology Identified	Description
53	100m	0.4	No archaeological deposits identified

<p>Topsoil was removed directly onto subsoil which varied between a light grey stoney silty clay and a light brownish-orange silt clay. Plough marks are visible throughout the trench.</p>

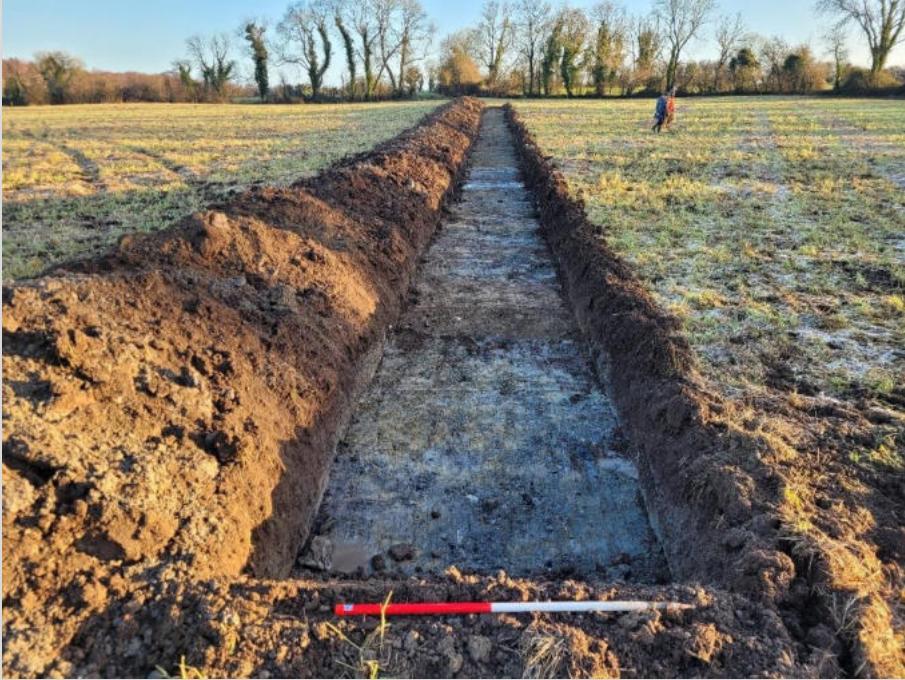
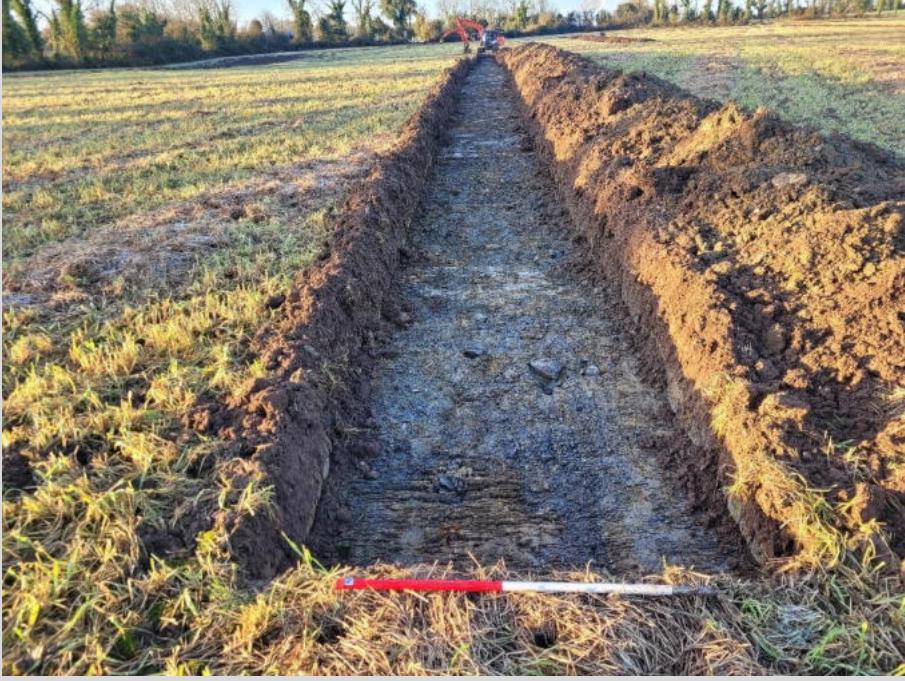
Topsoil was removed directly onto subsoil which varied between a light grey stoney silty clay and a light brownish-orange silt clay. Two field boundaries, numbered as [10] and [14] on the geophysical survey, extended north-south across the trench.

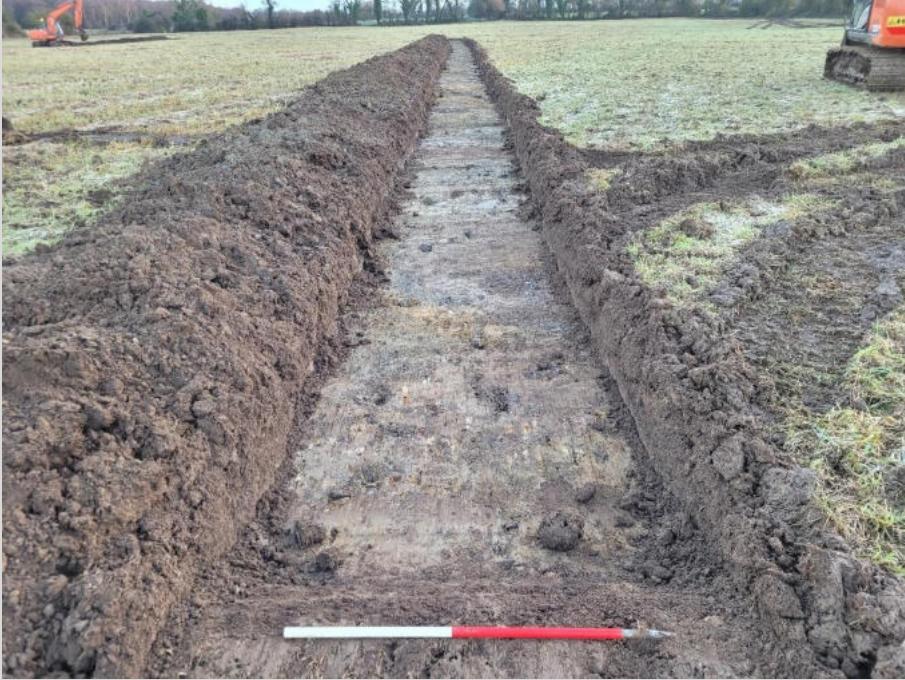
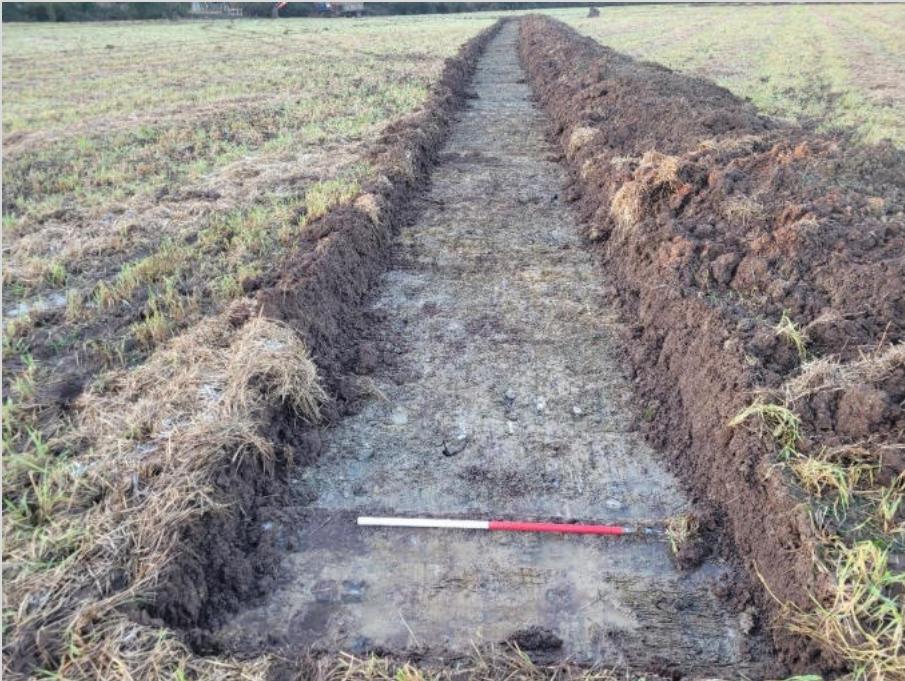
<p>Topsoil was removed directly onto subsoil which varied between a light grey stoney silty clay and a light brownish-orange silt clay. A field boundary, numbered as [9] on the geophysical survey, extended north-south across the trench.</p>			
<p>Looking northeast</p>

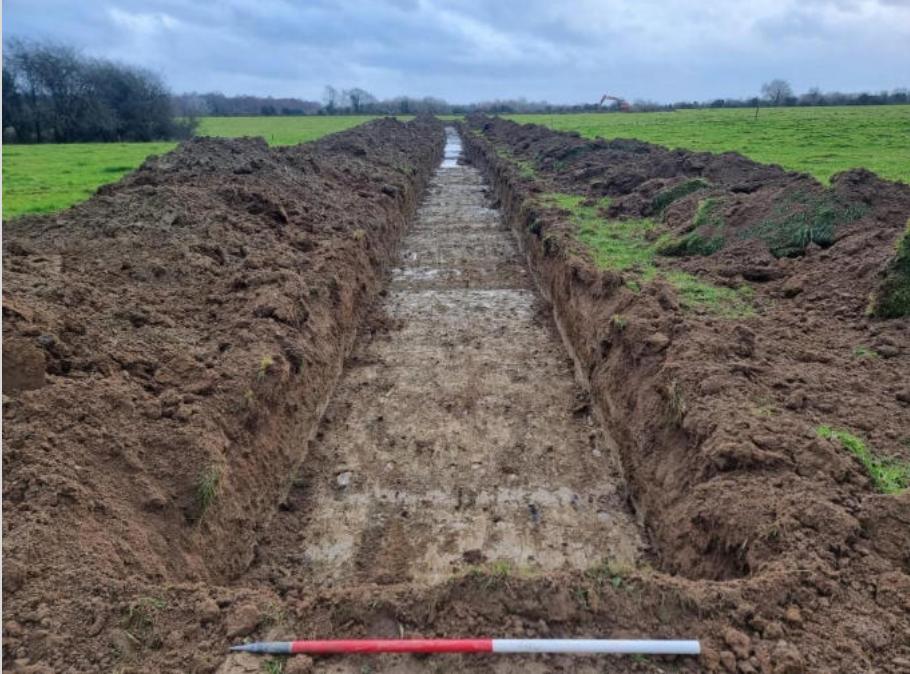
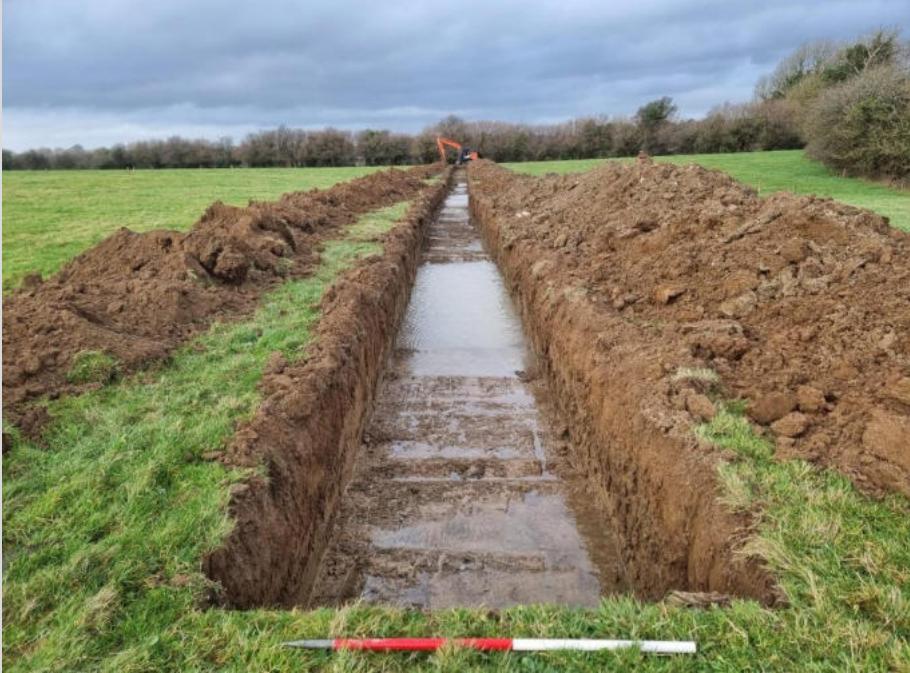
Topsoil was removed directly onto subsoil which consisted of a brownish-orange silty clay with occasional angular stone inclusions. Displacement of groundwater following heavy rainfall resulted in this trench filling with water during the course of excavation.

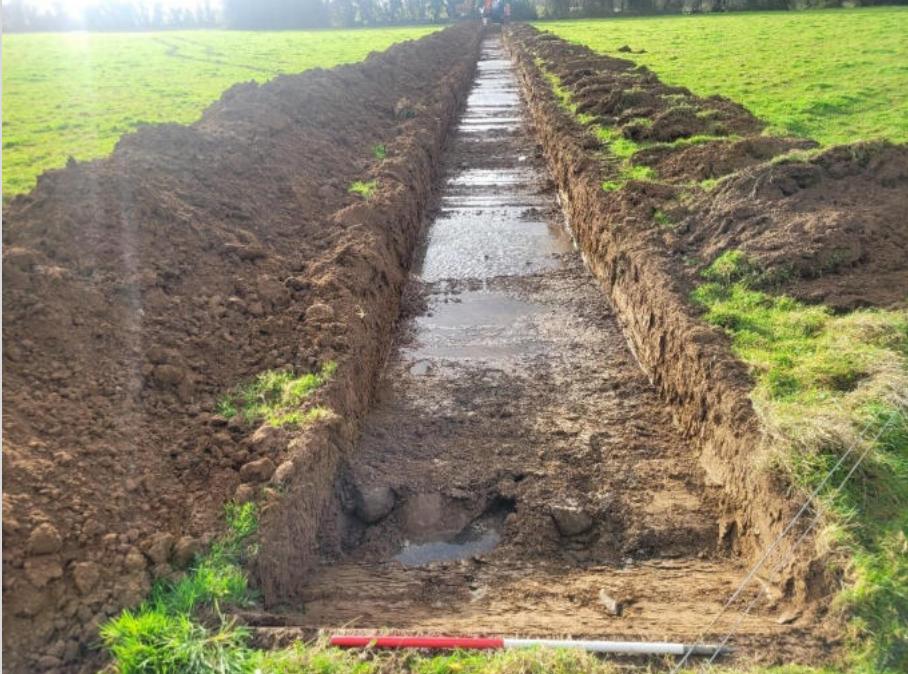
<p>Southern half of trench 57, looking southwest</p>

Trench Number	Length	Depth (m)	Archaeology Identified	Description
57	100m	0.45	No archaeological deposits identified	Topsoil was removed directly onto subsoil which consisted of a brownish-orange silty clay with occasional angular stone inclusions. Displacement of groundwater following heavy rainfall resulted in this trench filling with water during the course of excavation.

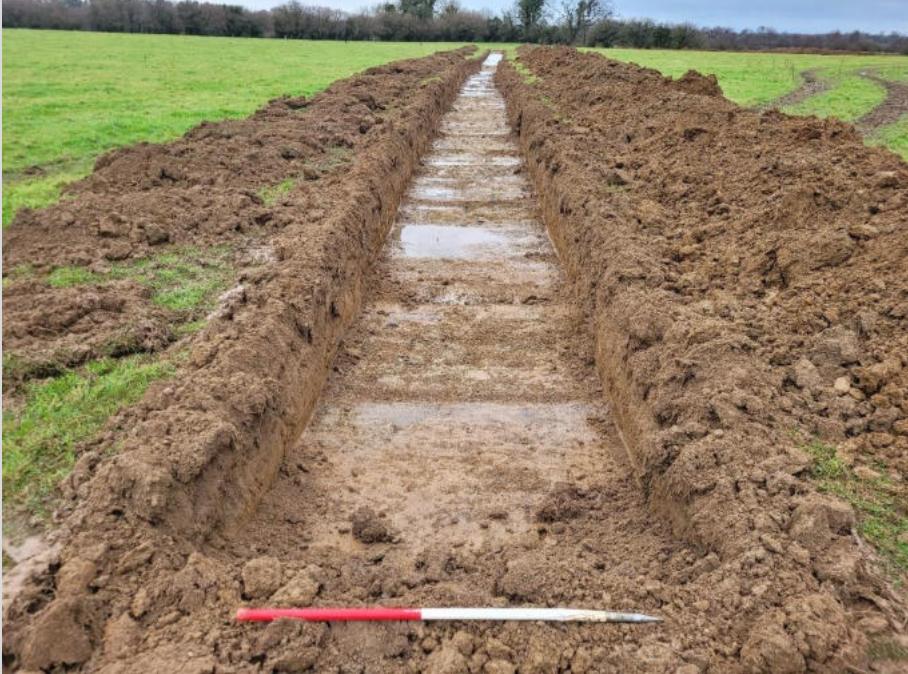
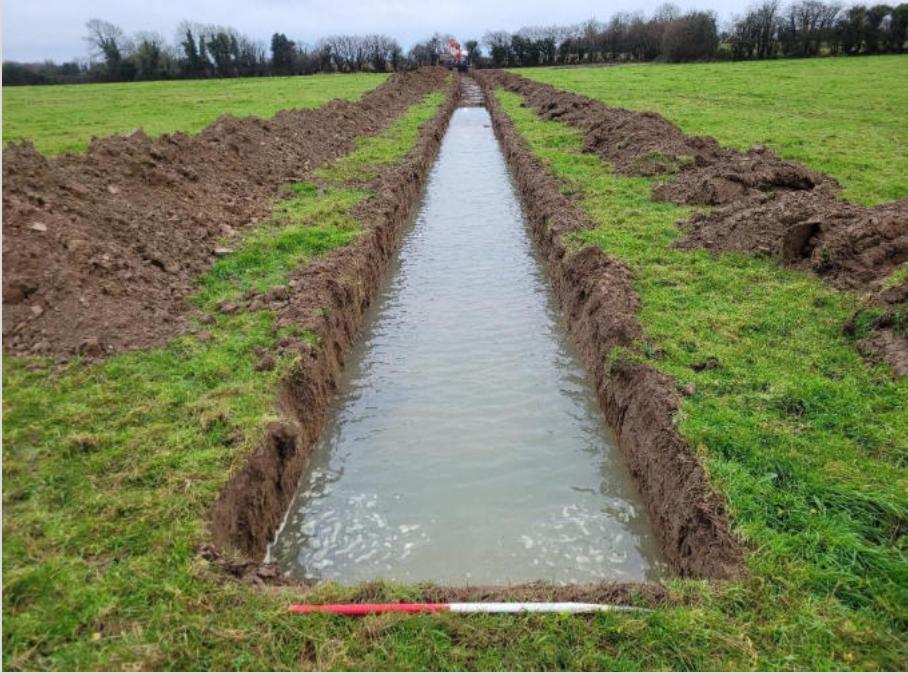
Topsoil was removed directly onto subsoil which consisted of a brownish-orange silty clay. The ground was extremely waterlogged at the northeastern end of the trench and displacement of groundwater following heavy rainfall resulted in this trench filling with water during the course of excavation

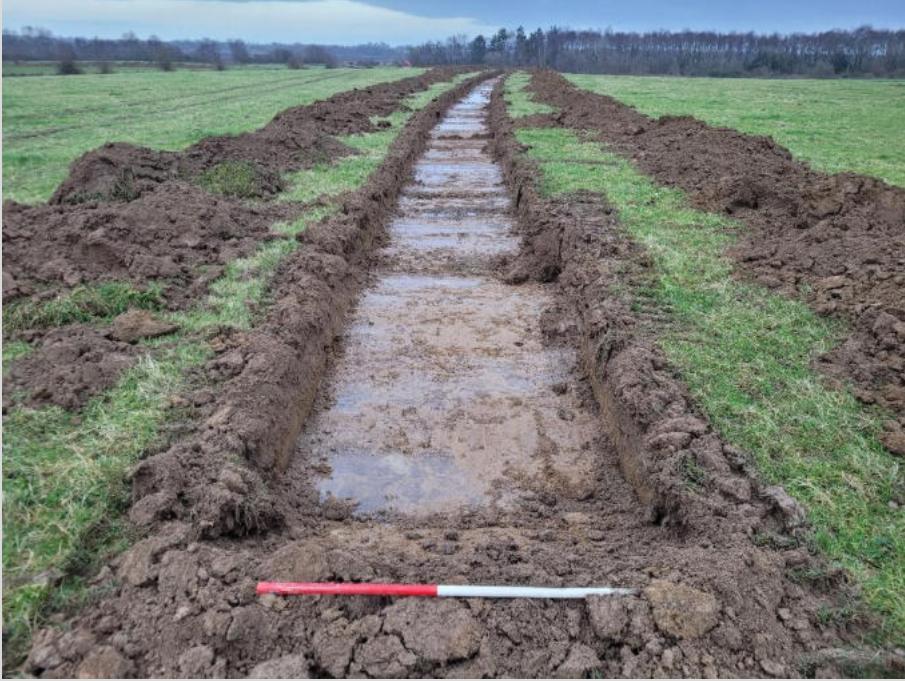
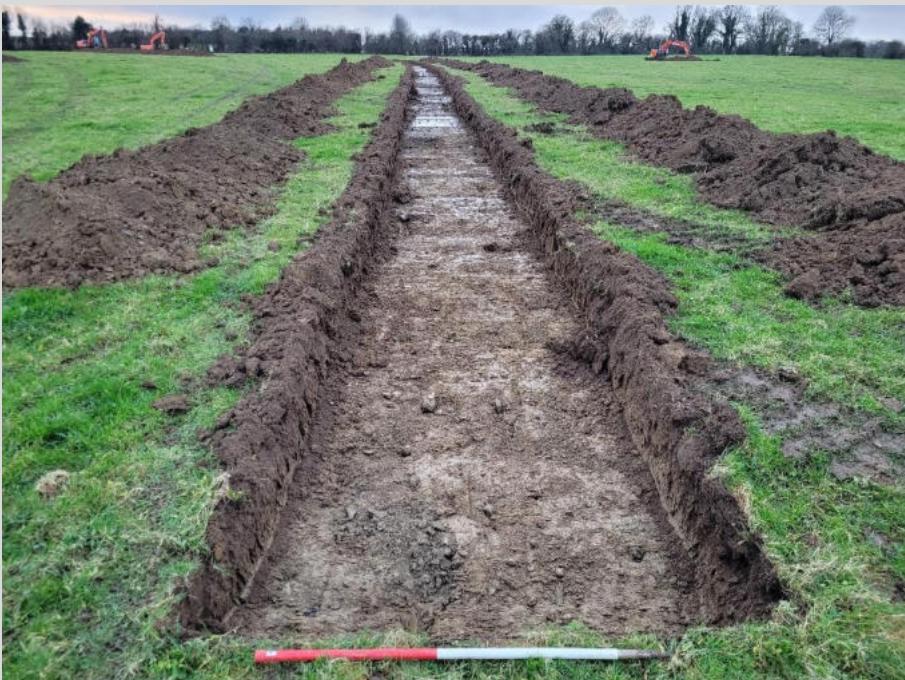
Topsoil was removed directly onto subsoil which consisted of a brownish-orange silty clay with occasional angular stone inclusions.			
<b>Looking northeast</b>

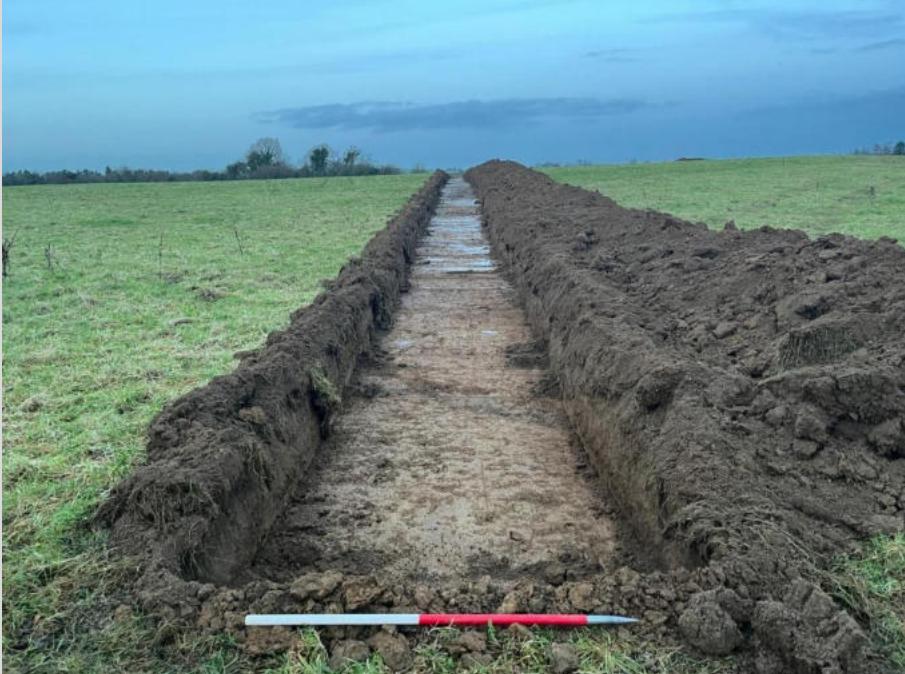
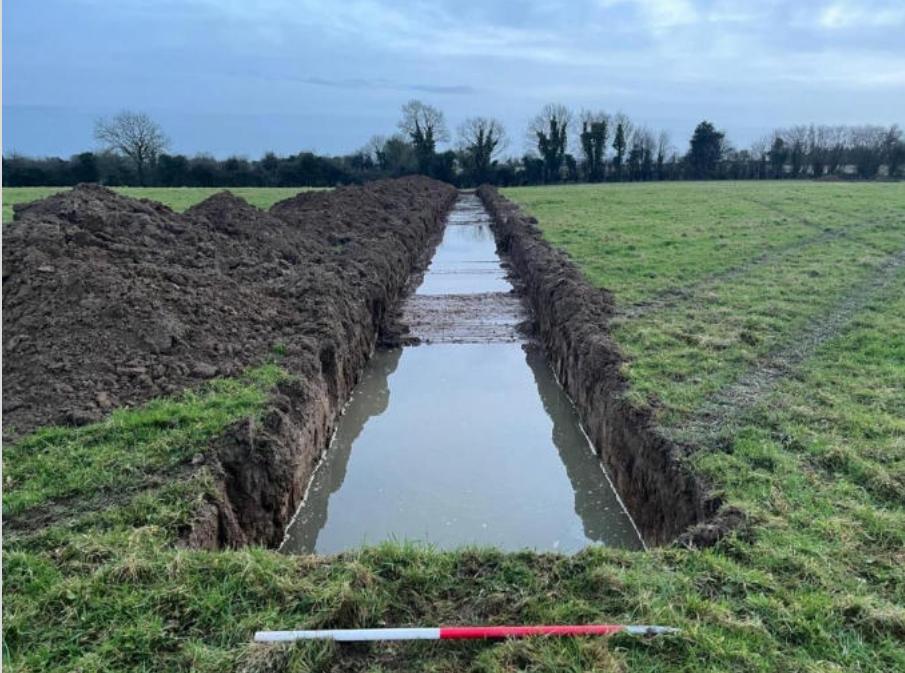
Looking north				Topsoil was removed directly onto subsoil which consisted of a brownish-orange silty clay. The ground was extremely waterlogged at the northern end of the trench and displacement of groundwater following heavy rainfall resulted in this trench filling with water during the course of excavation

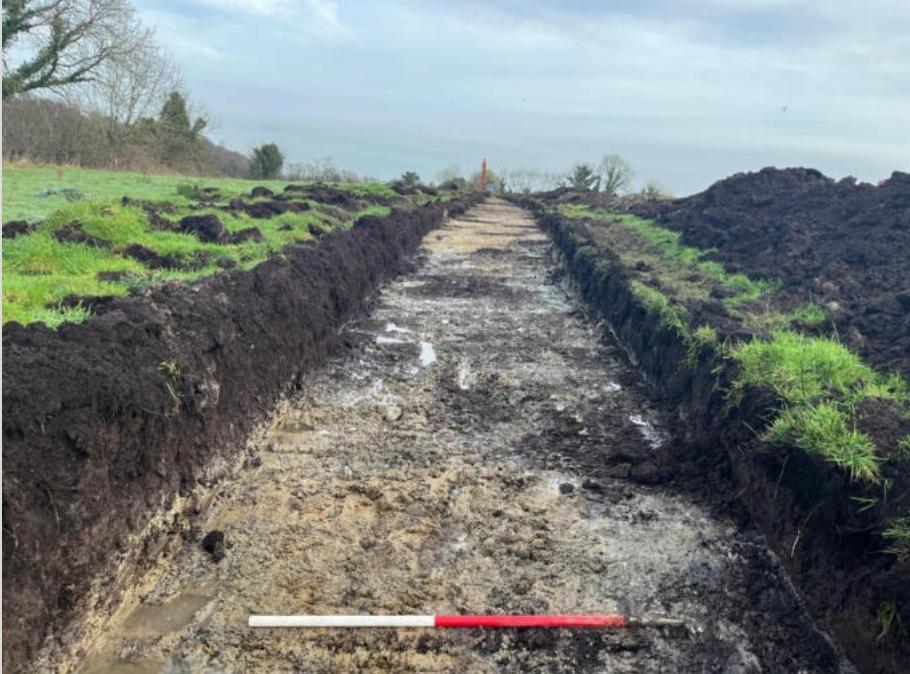
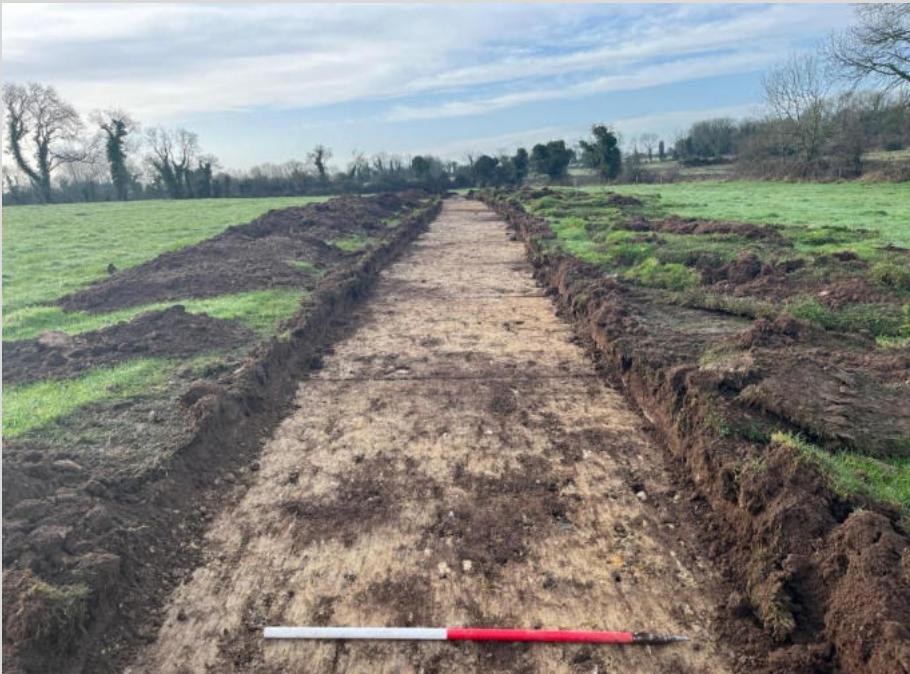
Topsoil was removed directly onto subsoil which consisted of a firm greyish-yellow silty clay with frequent angular stone inclusions. In the central portion of the trench, a deposit [23] consisting of black silty clay with frequent cracked stone and charcoal inclusions was identified. This deposit was not identified during the geophysical survey, but it does represent a potential archaeological feature. The field boundary [16] was not visible.

The excavation of trench 62 revealed a deposit of black silty clay with frequent cracked stone and charcoal inclusions (plate 17). The deposit [23] measured 3m northeast-southwest but extended beyond the limit of the trench to the northwest and southeast. This deposit likely represents a burnt stone mound.

Trench No.	Feature No	Description	Mitigation
42	22	Charcoal rich circular pit- high archaeological significance	Solar arrays to be erected on supports with concrete feet within area shown on figure 13. All cabling to be above ground.
62	23	Burnt mound- high archaeological significance	Solar arrays to be erected on supports with concrete feet within area shown on figure 13. All cabling to be above ground.

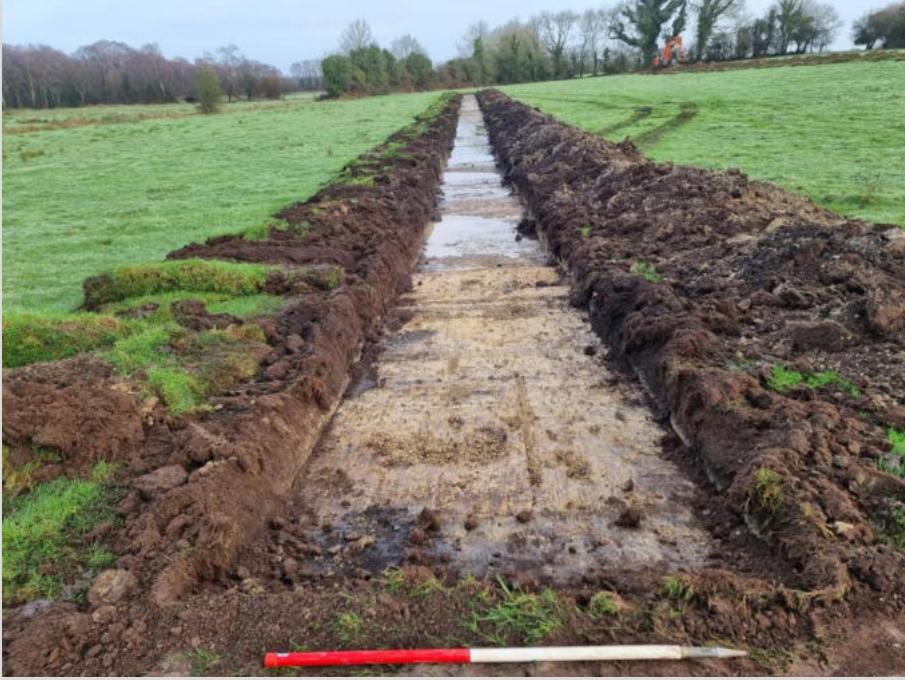
Trench Number	Length	Depth (m)	Archaeology Identified	Description
63	100m	0.3-0.4	No archaeological deposits identified	Topsoil was removed directly onto subsoil which consisted of a brownish-orange silty clay.

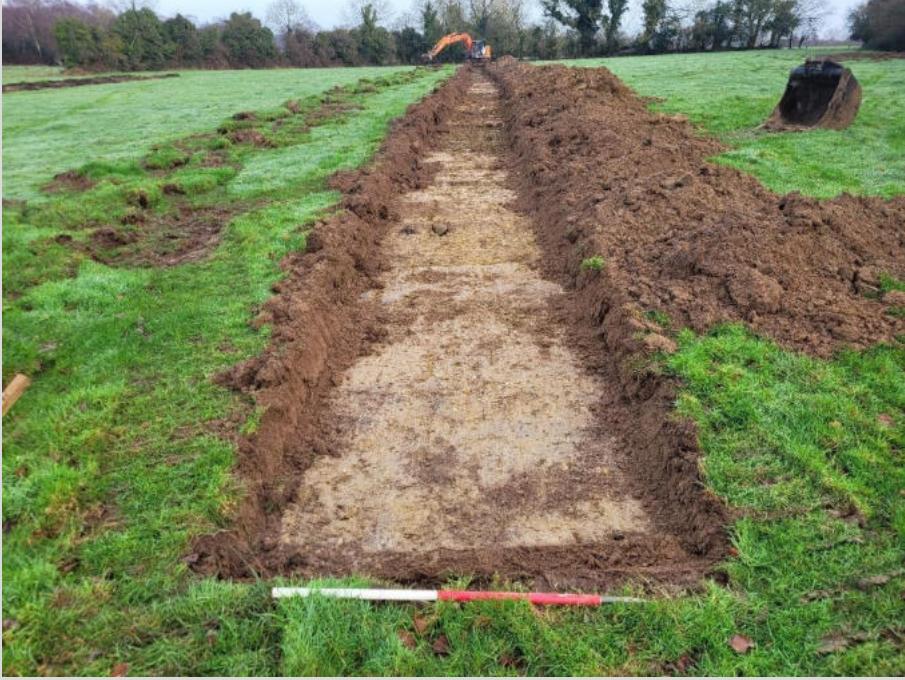
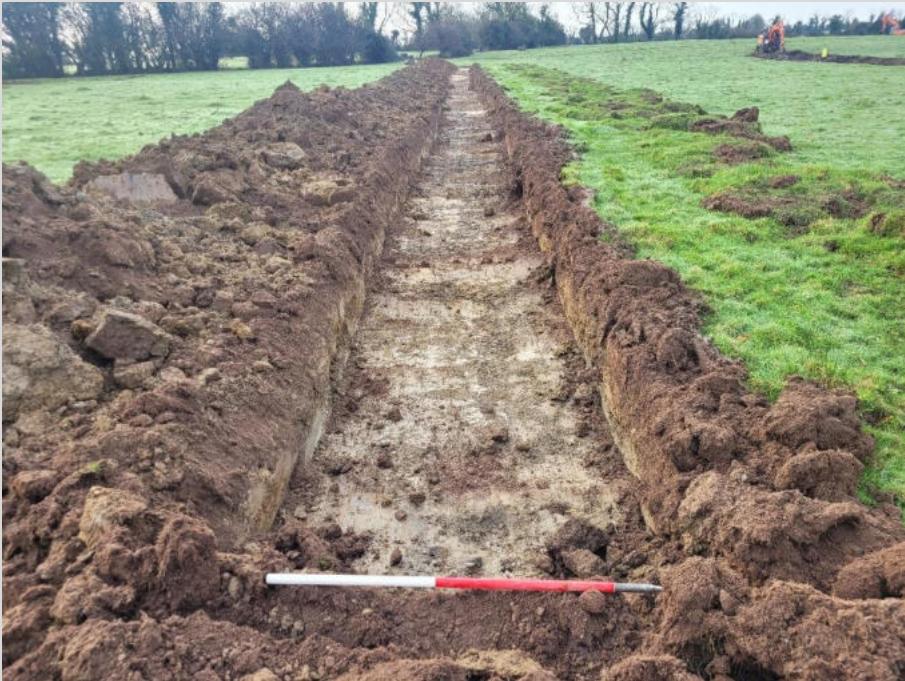
Trench Number	Length	Depth (m)	Archaeology Identified	Description
64	100m	0.35	No archaeological deposits identified	Topsoil was removed directly onto subsoil which consisted of a light grey stoney silty clay.
